AORERE STAGE 2 – TOC45

Superlot AO-019

Geotechnical Completion Report

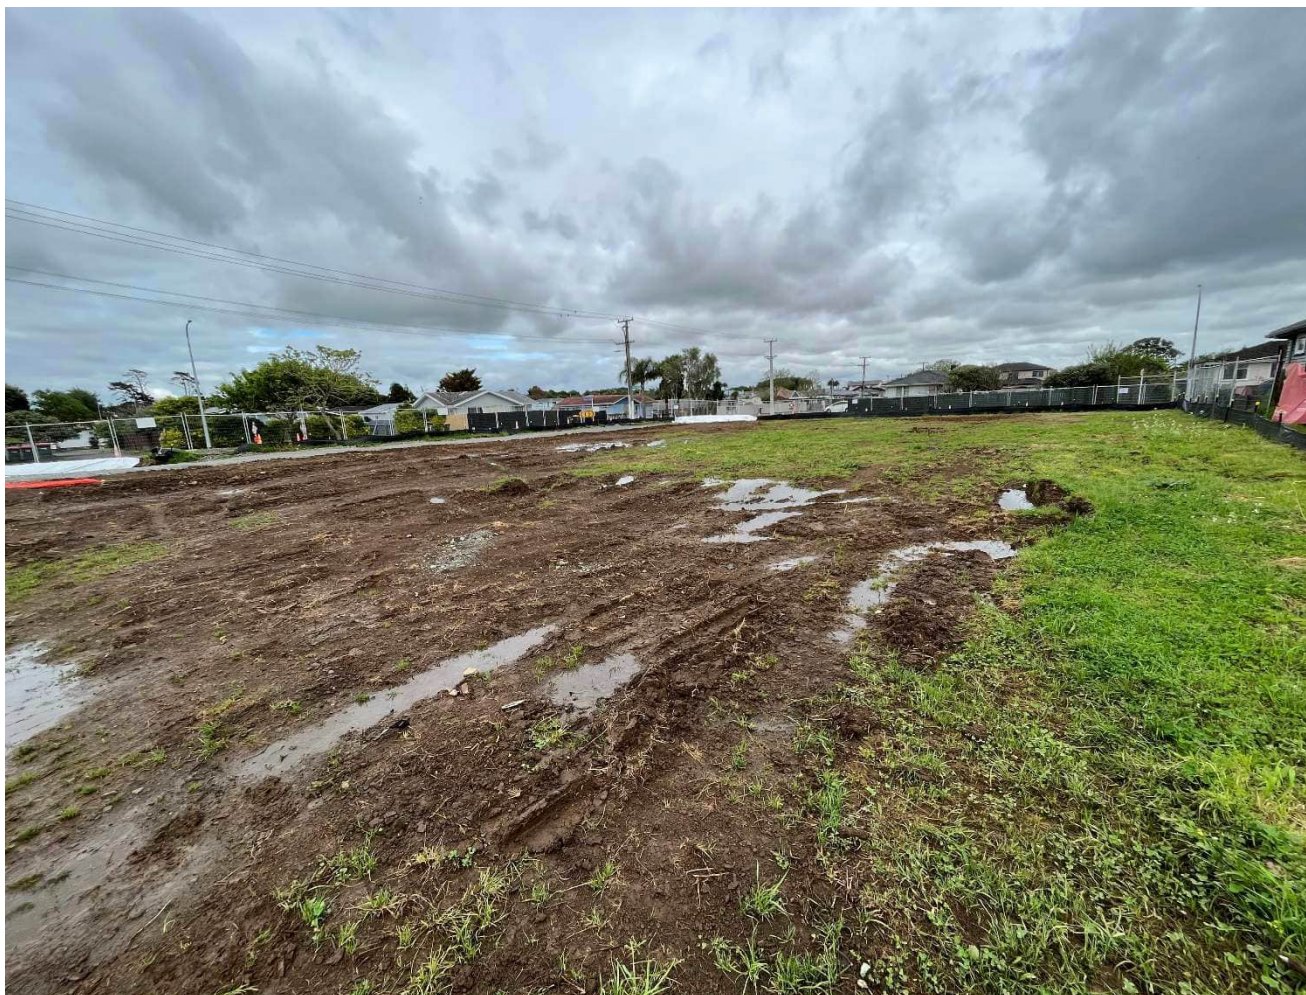
Photograph 1: Site overview, looking West.

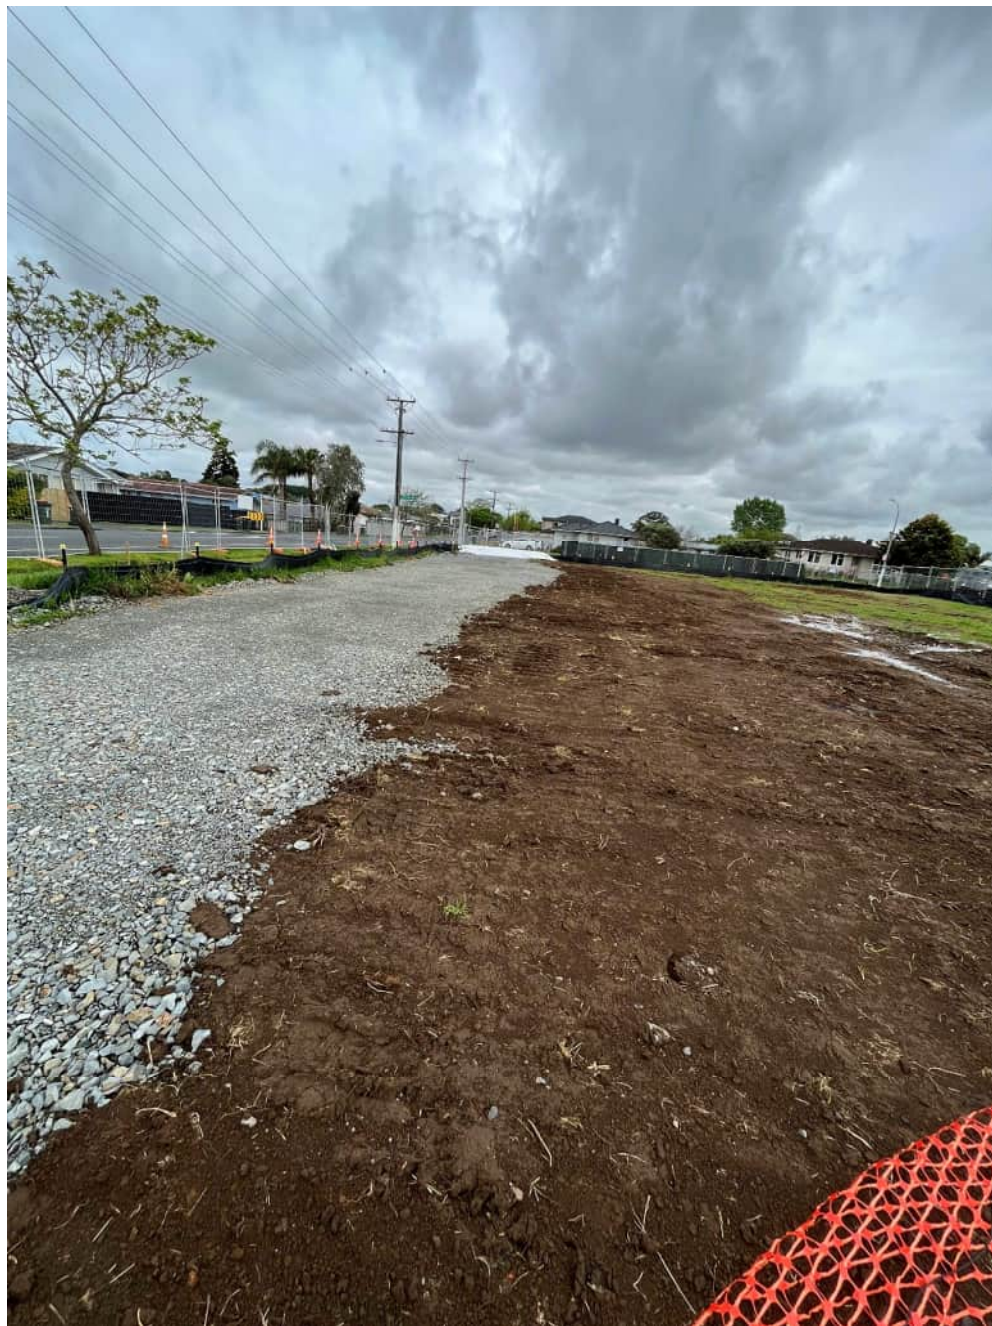
Photograph 2: 3 m wide Granular backfill strip on Superlot boundary with Henwood Road.
