AORERE STAGE 2 – TOC45

Superlot AO-016

Geotechnical Completion Report

AORERE STAGE 2 – SUPERLOT AO-016– GEOTECHNICAL COMPLETION REPORT

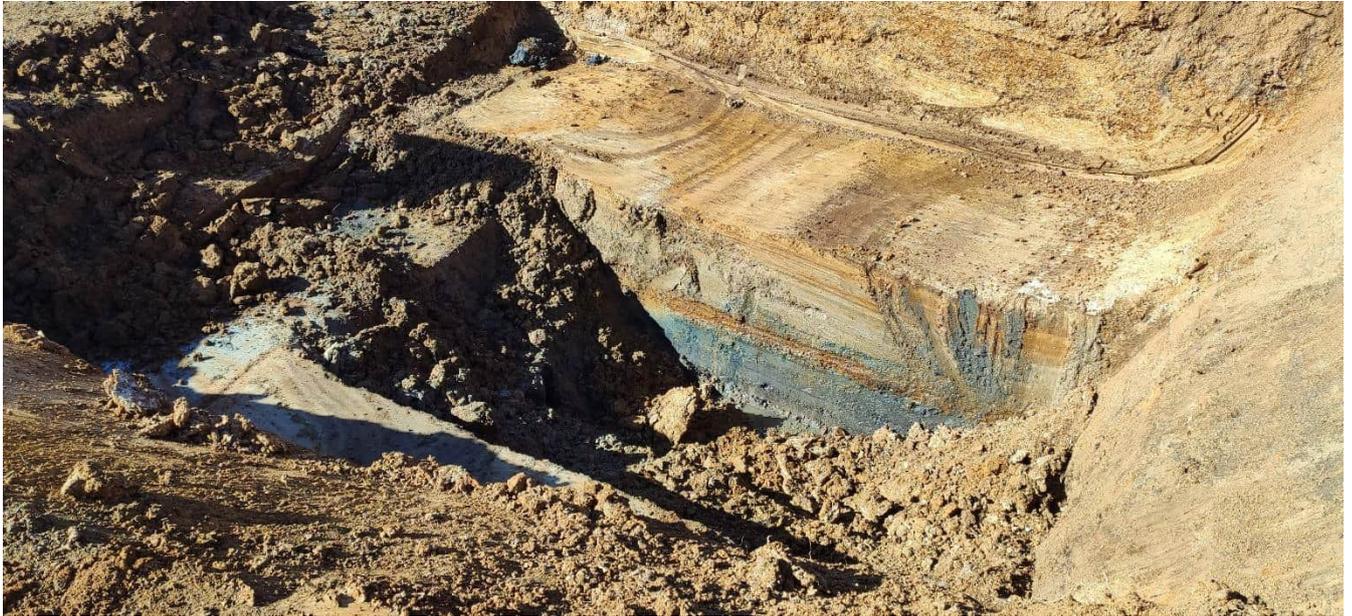
Photograph 1: Overview of excavation for WWMH C-1

<p>Agreements/recommendations onsite:</p> <ul style="list-style-type: none"> - Recommended, based on the shear vane results, an undercut of 500 mm as per the wastewater ITP. - Recommended carrying out ongoing observations of the soil beneath the excavator as a health and safety precaution as it looked a little unstable. 	
<p>Follow-ups and further actions required:</p> <ul style="list-style-type: none"> - Follow up with construction team on visit for next manhole WWMH C-2 - Follow up on backfill methodology. - Follow up on QA testing following backfill.

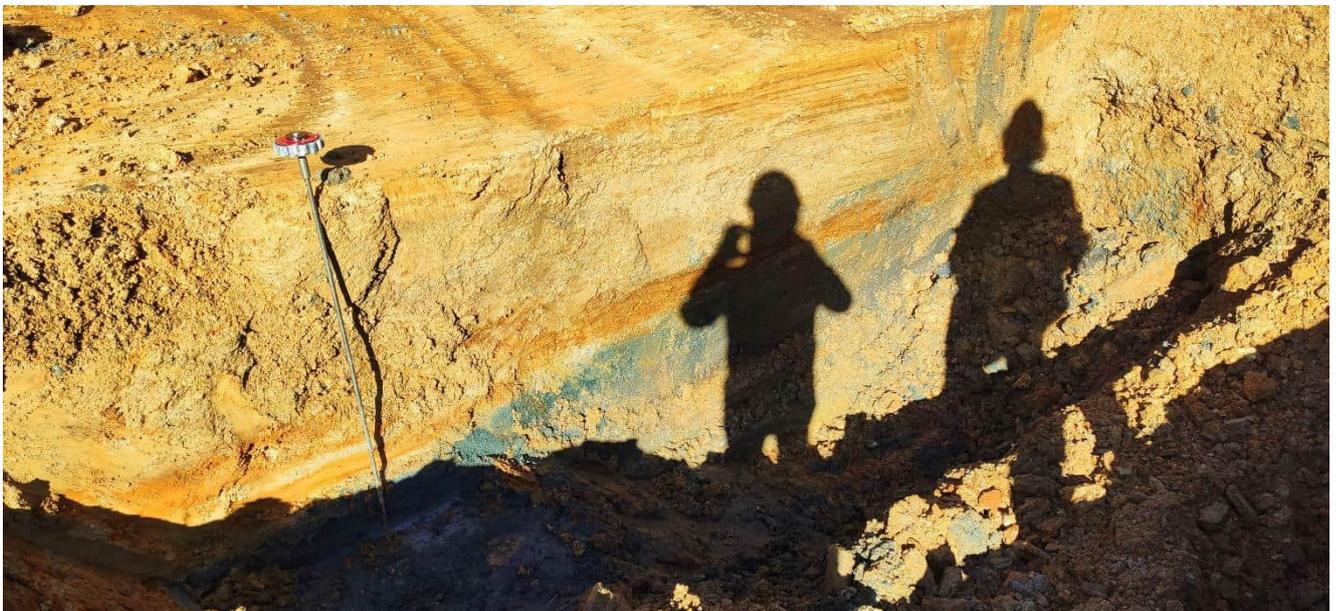
Photograph 2: Transition from AVF to Alluvium.

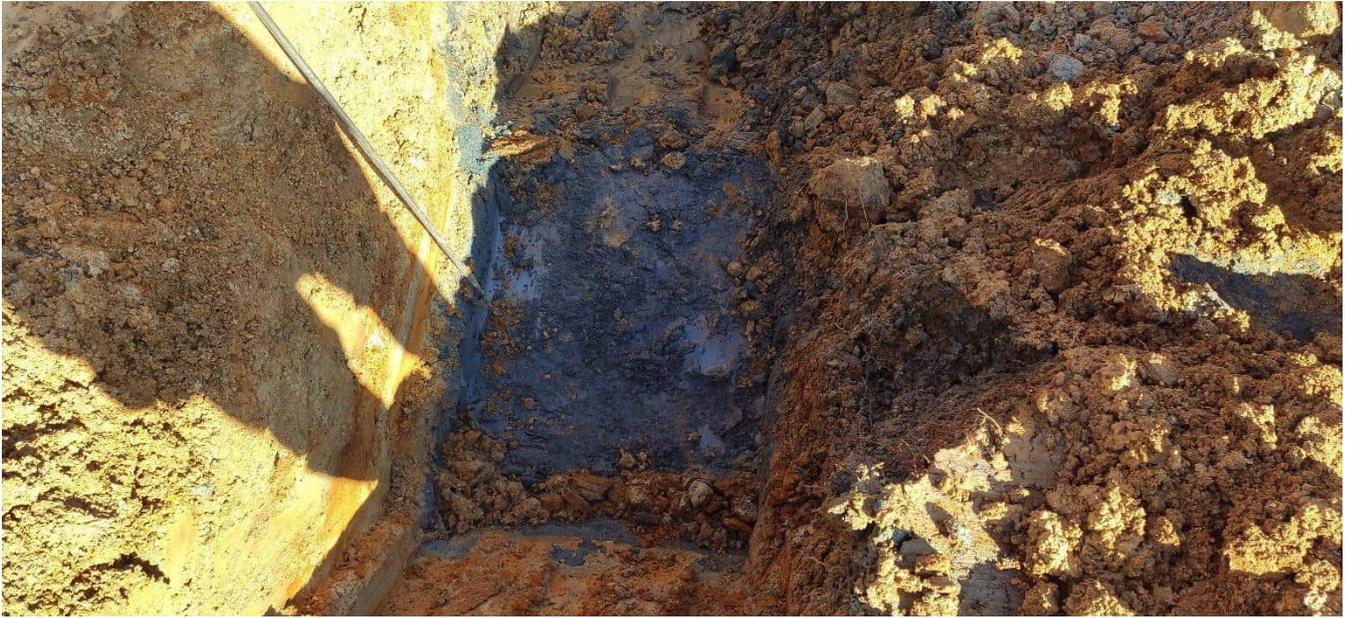
Testing of the subgrade at the manhole foundation level was undertaken by the Piritahi Geotechnical Engineer, recording an undrained shear strength of 20 to 40 kPa. Backfill of the manhole undercut was undertaken using GAP65 hardfill. Clegg hammer tests on the GAP65 hardfill recorded Clegg Impact Values between 30 and 40. The manhole trench was backfilled with cohesive material (silt and clay). Shear vane testing was undertaken by the Piritahi site team on the cohesive material, measuring undrained shear strength between 145 kPa and 171 kPa, averaging 152 kPa. The test results achieved the compaction requirement of the Piritahi Wastewater ITP. The new wastewater manhole installed is shown in Appendix B – As Built Plans. The backfill records are provided in Appendix C – Piritahi Test Results.

Photograph 3: Shear vane testing in the Alluvium at the manhole subgrade level.

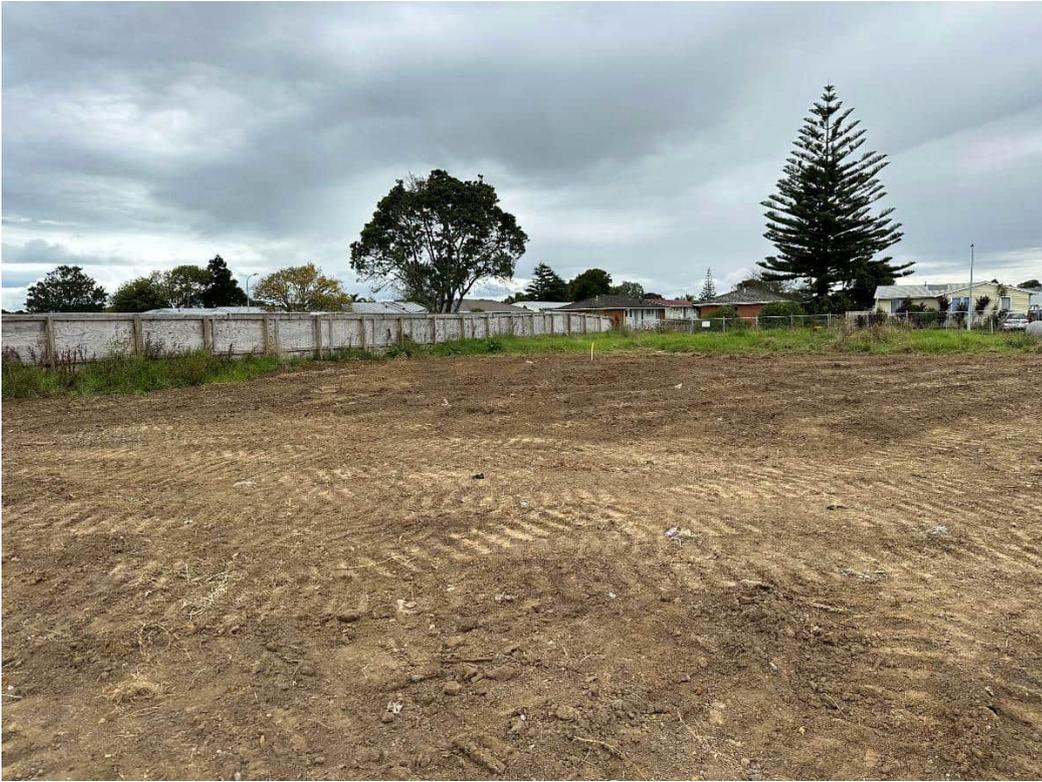
Photograph 1: Superlot overview – looking west

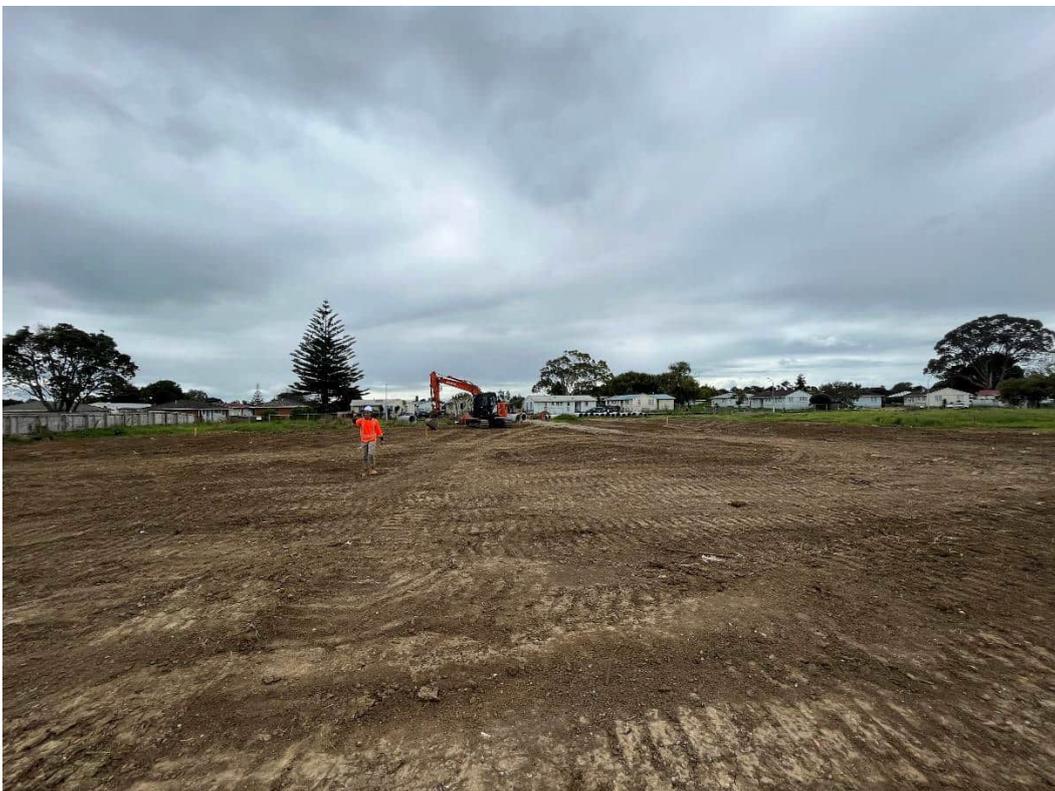
Photograph 2: Superlot overview – looking south

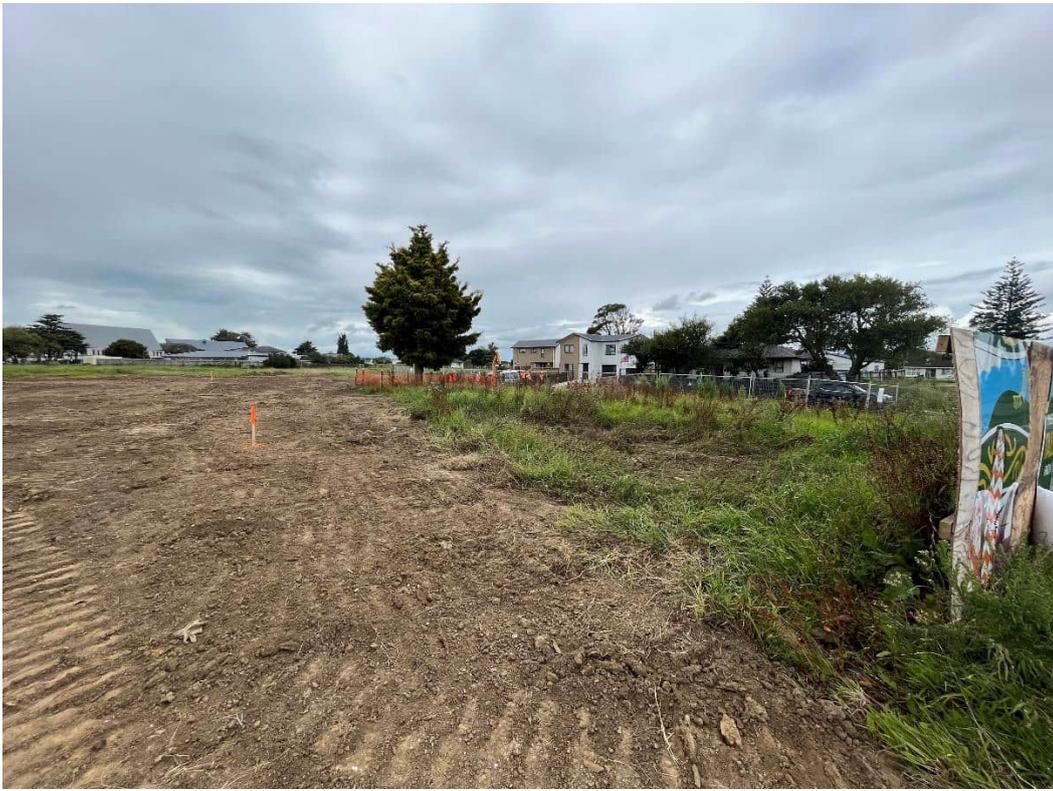
Photograph 3: Superlot overview – looking north
