# AORERE STAGE 2 – TOC45

Superlot AO-015

Geotechnical Completion Report

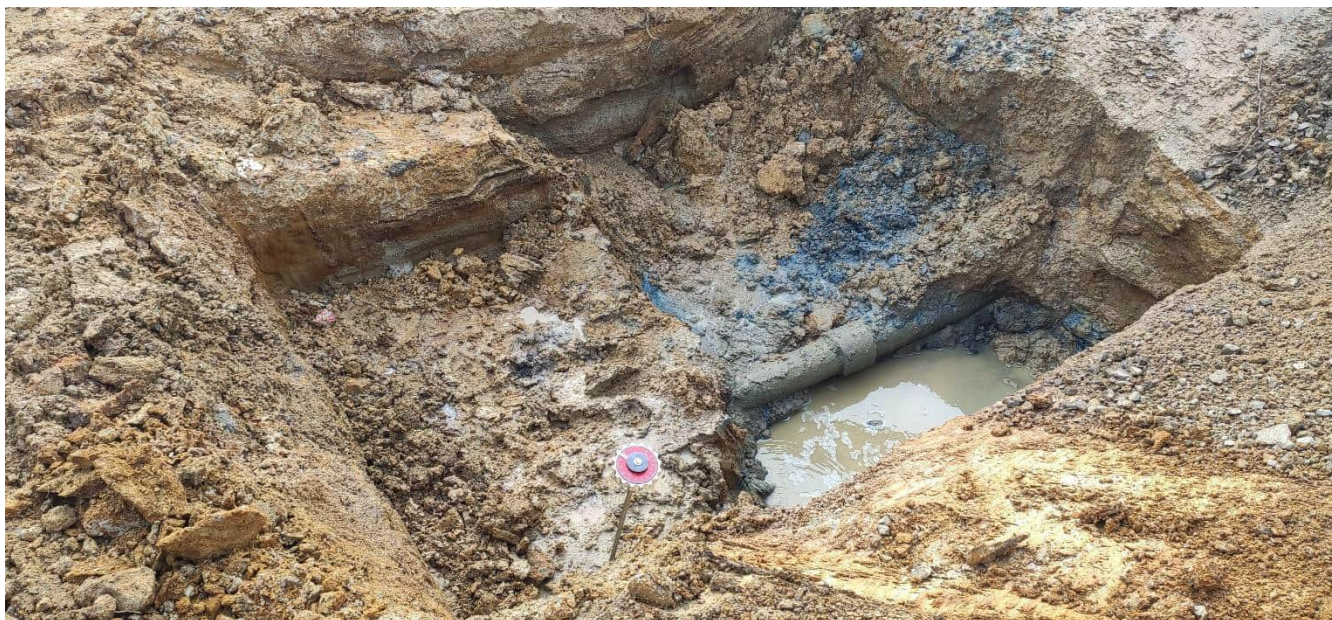
Photograph 1: Existing wastewater pipe visible running through centre of excavation. Blue grey alluvium at the base.

Agreements/recommendations onsite: - Recommended undercutting 500 mm based on the shear vane results and ITP requirements - Agreed compaction testing would be carried out by the construction team following compaction

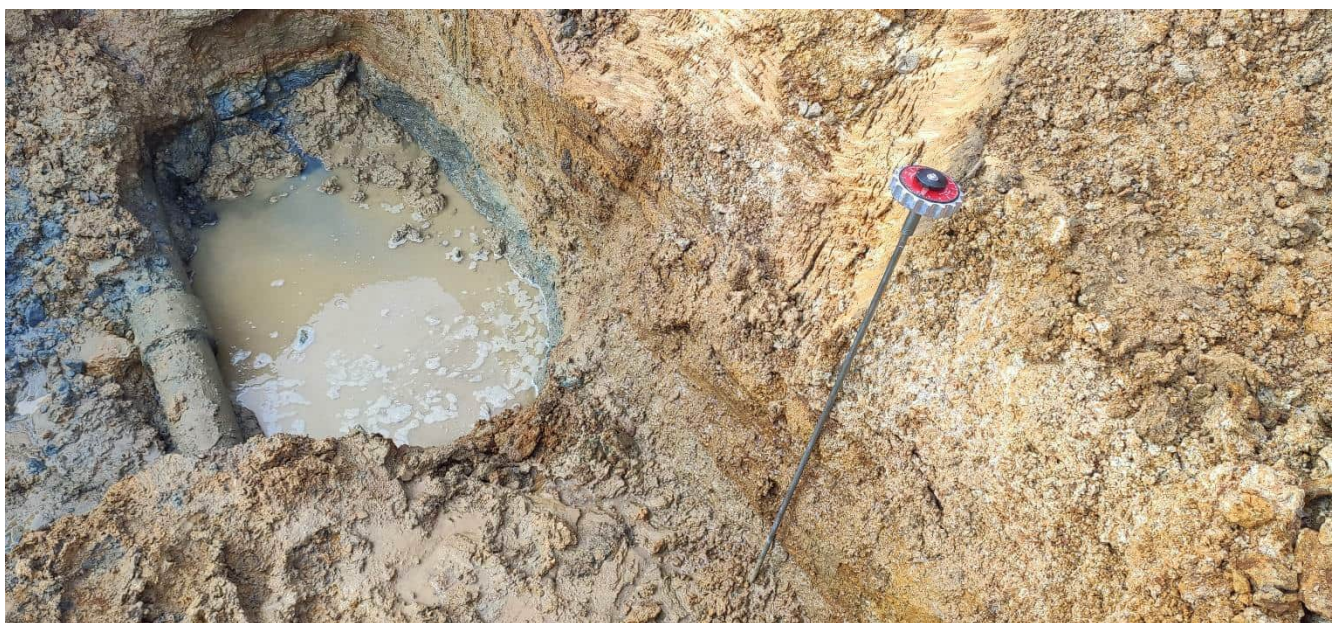
Photograph 2: Transition from AVF to Alluvium visible with groundwater seeping from the side walls.

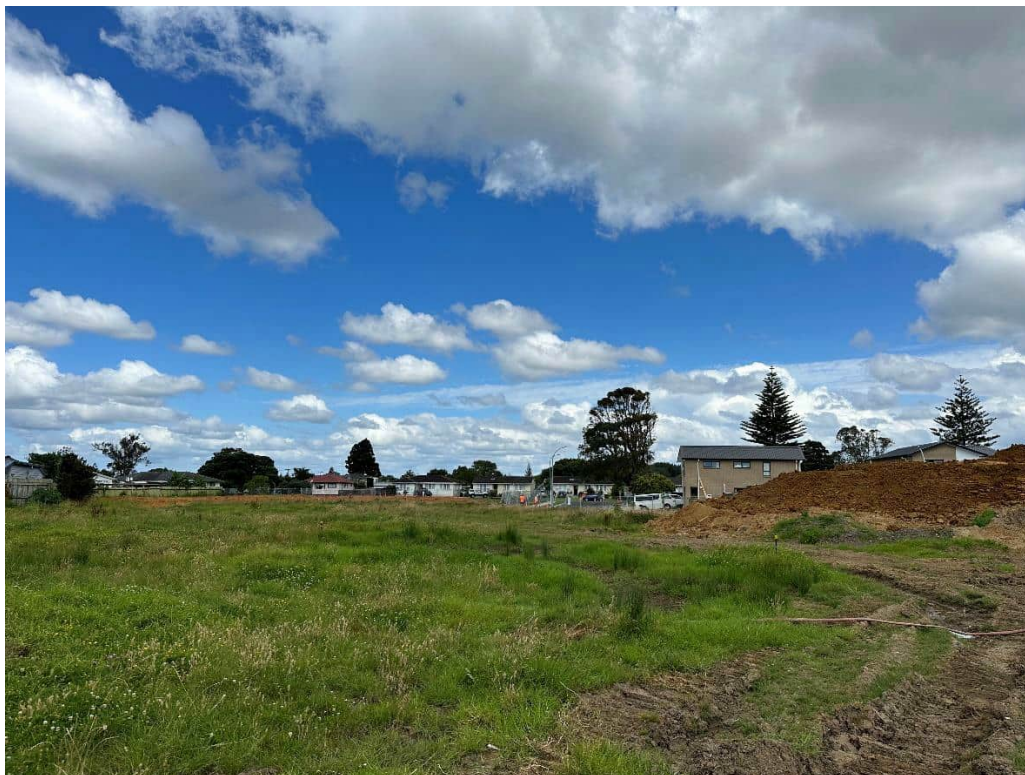
Photograph 1: Superlot overview – looking west

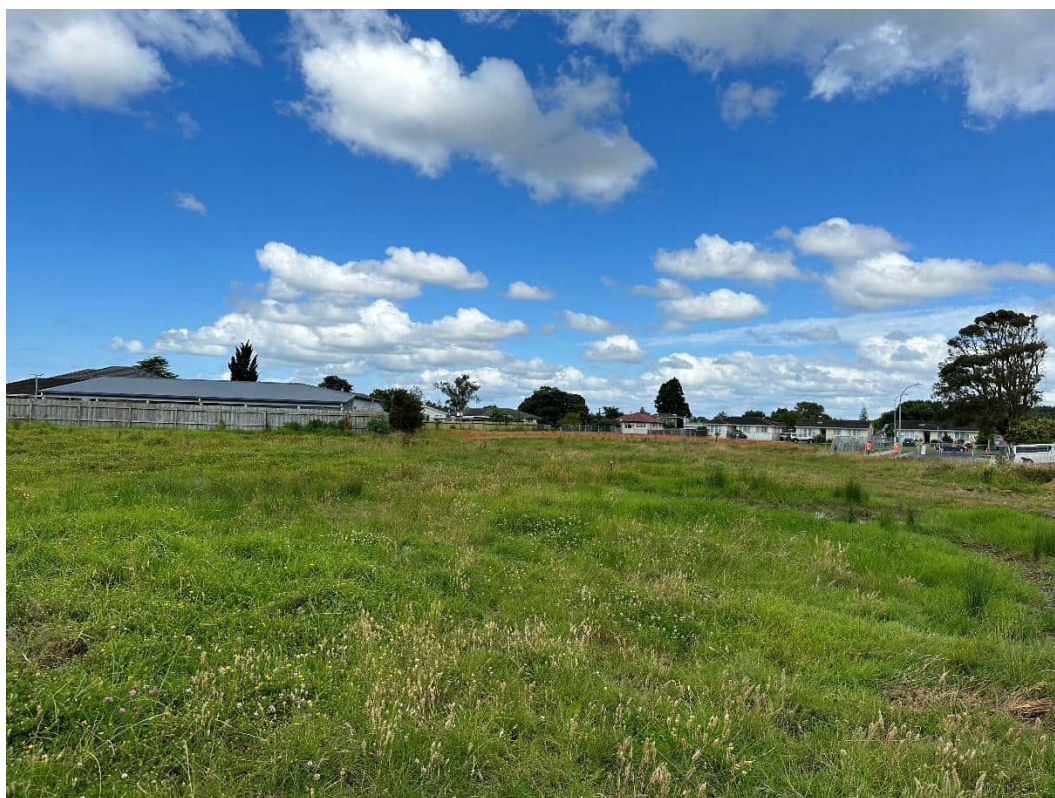
Photograph 2: Superlot overview – looking south

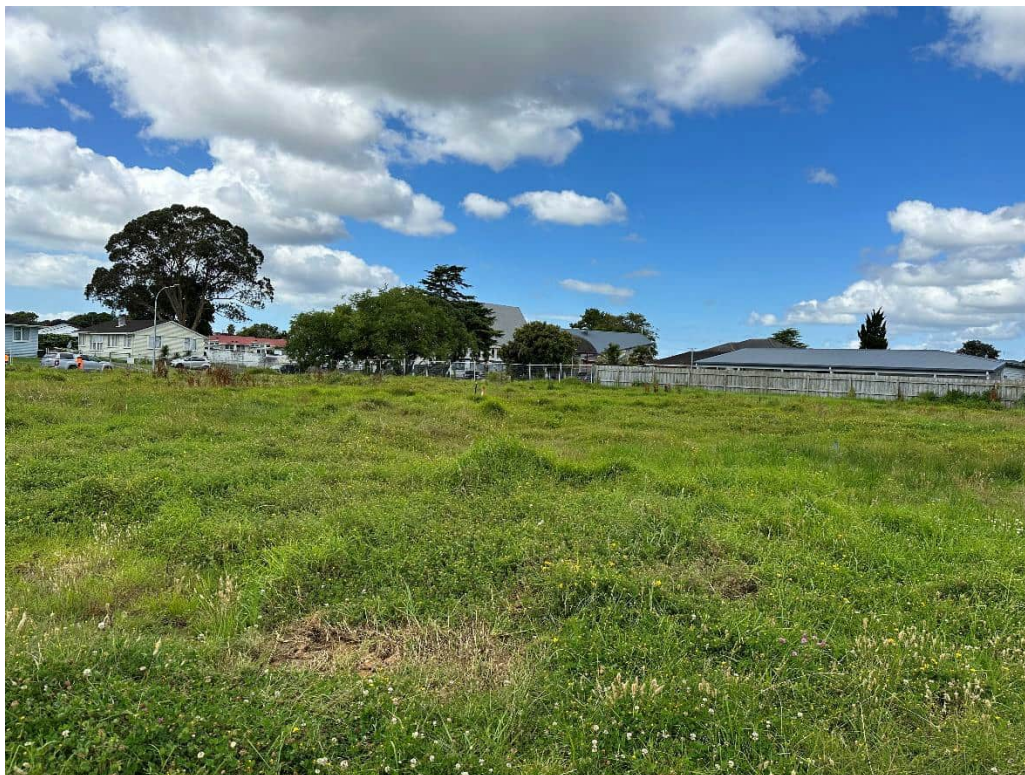
Photograph 3: Superlot overview – looking north

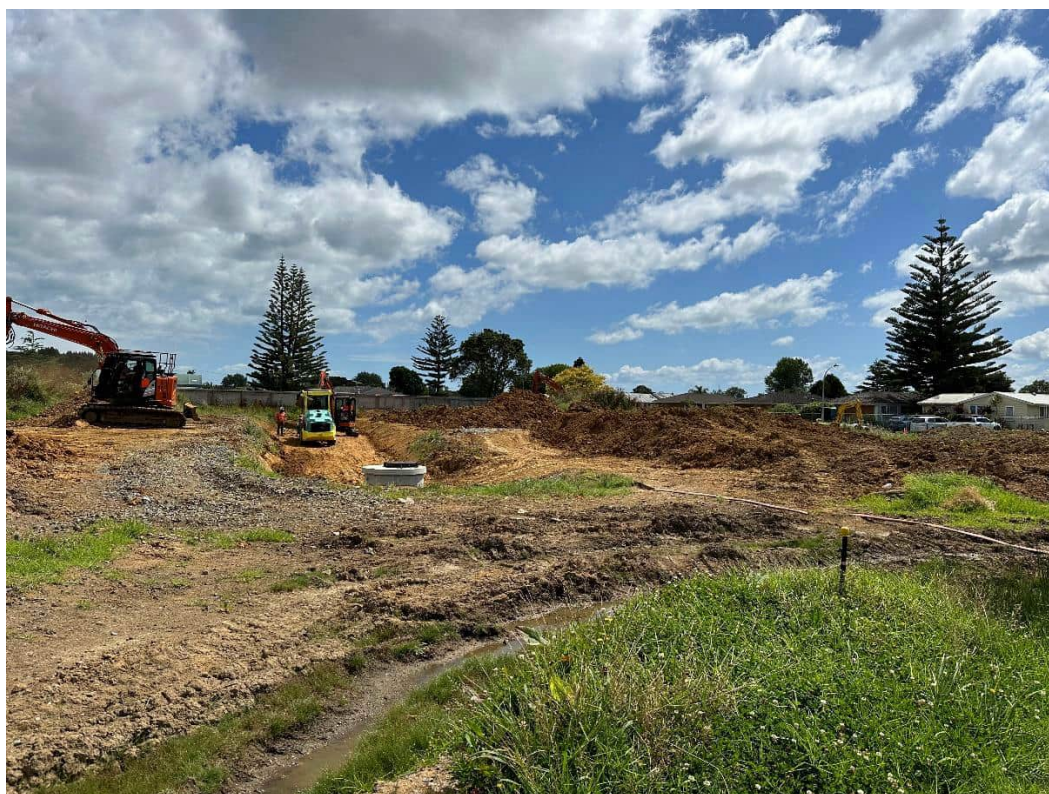
Photograph 4: Installation of the wastewater line

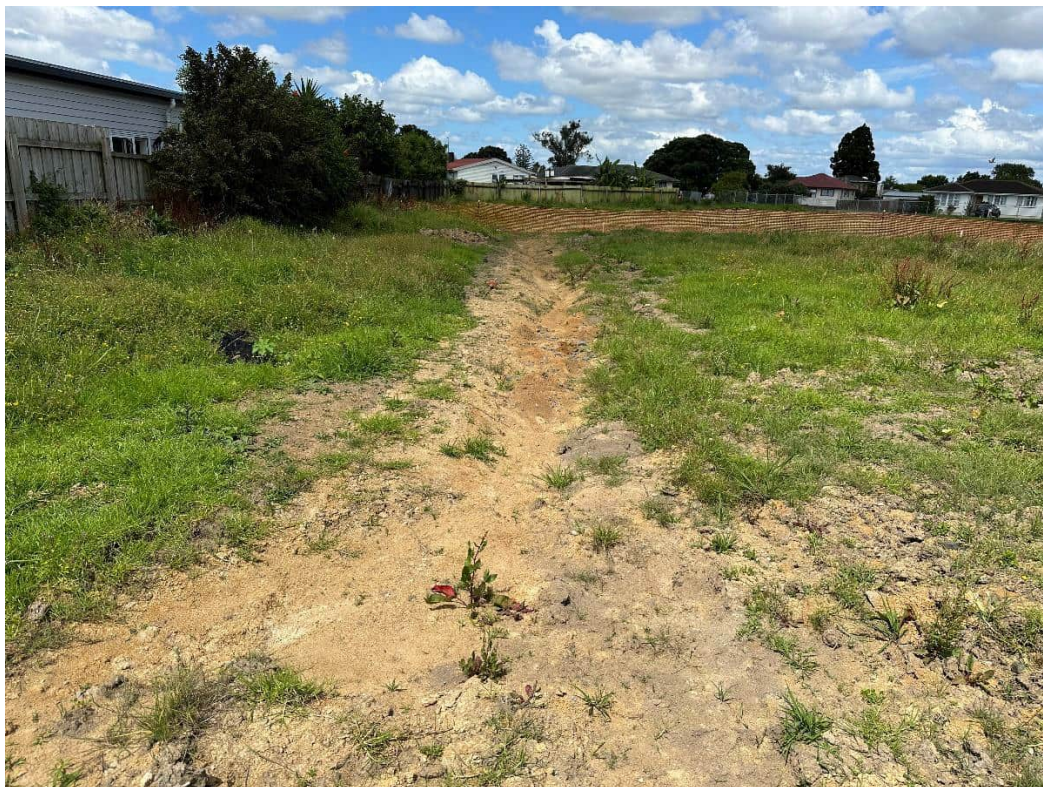
Photograph 5: Earth bund near the eastern boundary of the superlot

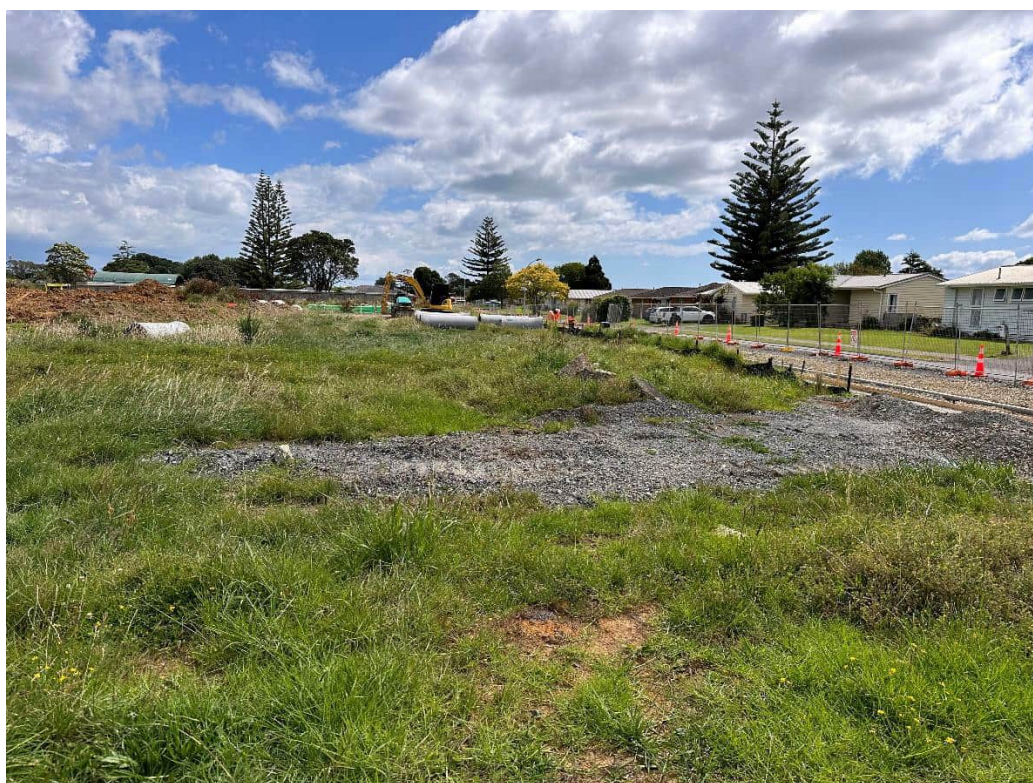
Photograph 5: Hardstand near the northern boundary (entrance) of the superlot

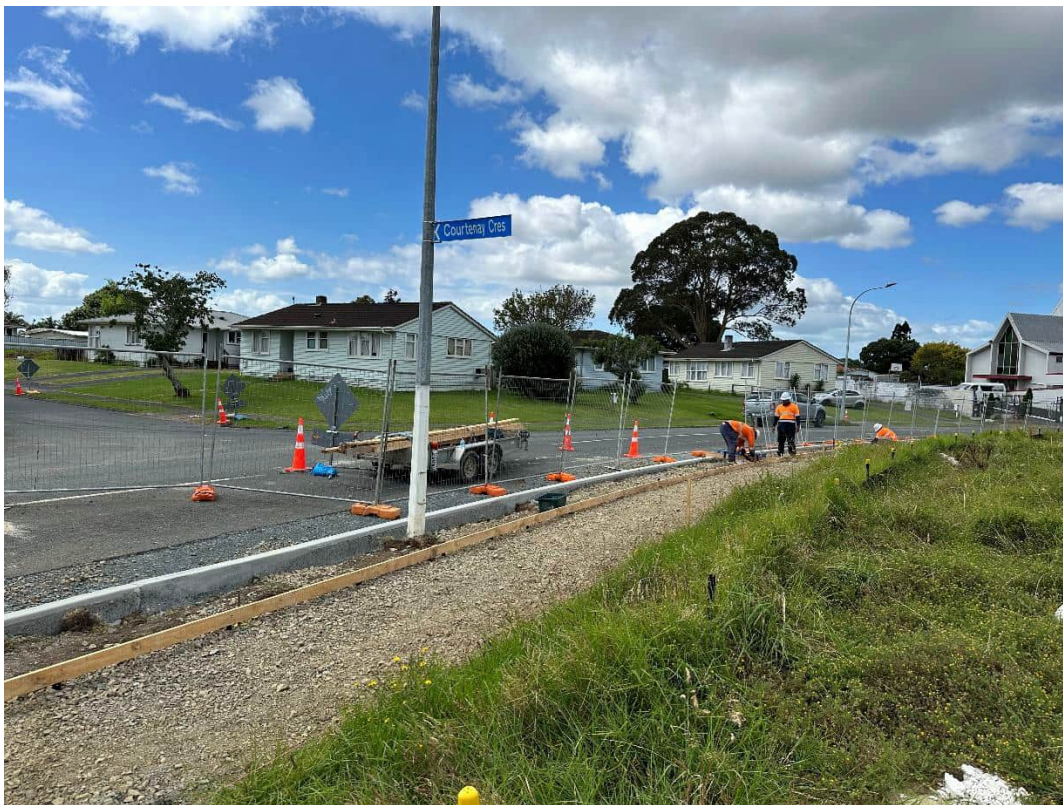
Photograph 6: Construction of sideway subgrade along Winthrop Way
