# AORERE STAGE 2 – TOC45

Superlot AO-018

Geotechnical Completion Report

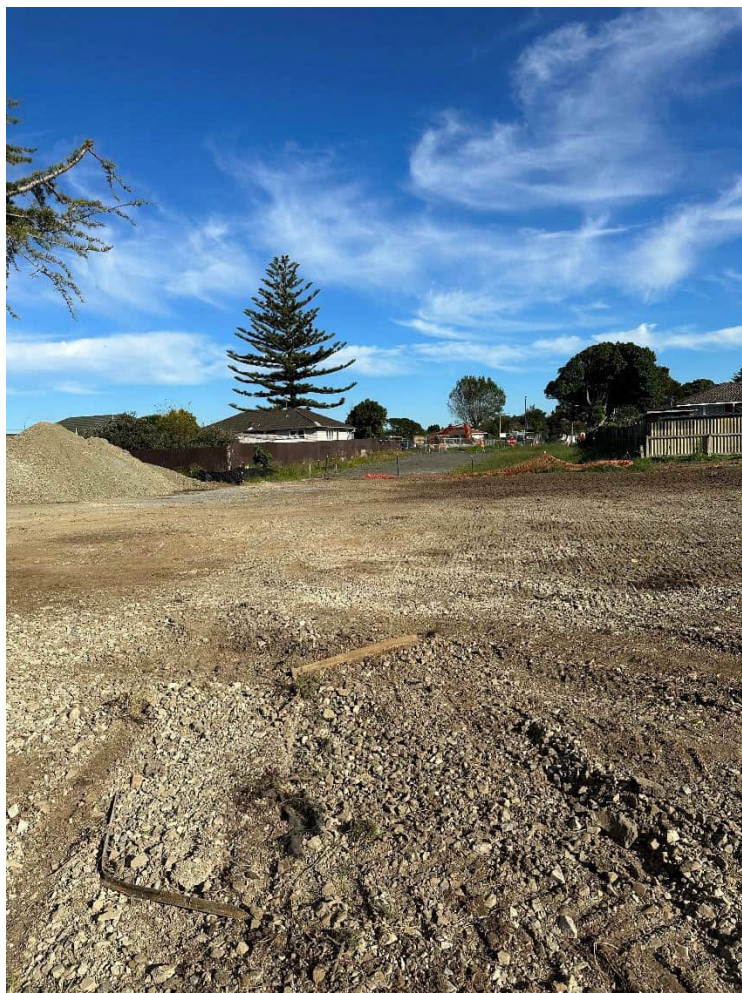
Photograph 1: Superlot overview – looking north west

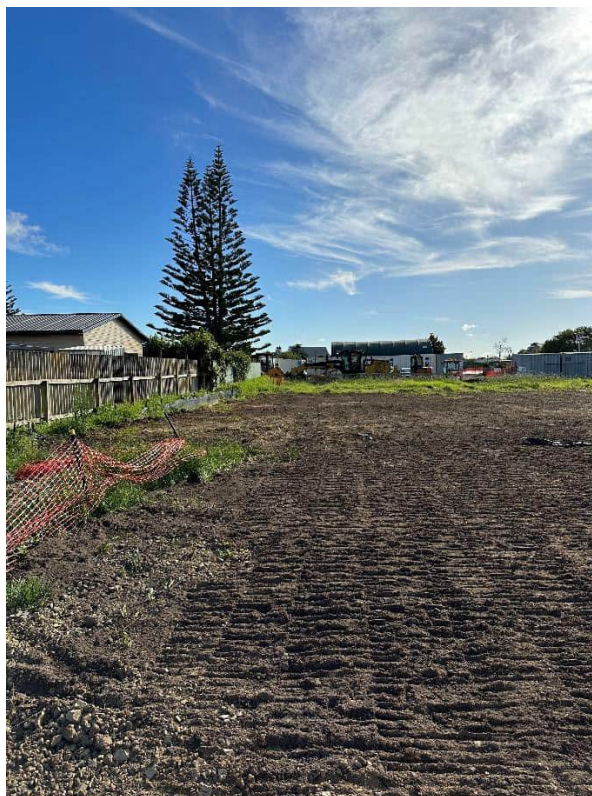
Photograph 2: Superlot overview – looking north east

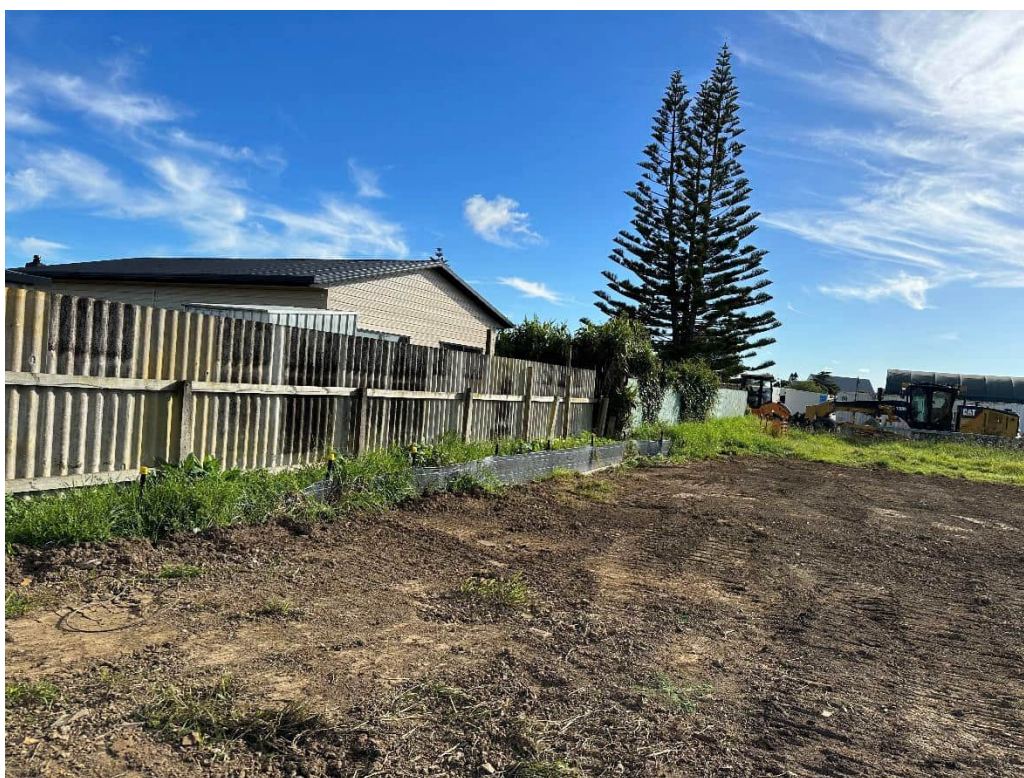
Photograph 3: Superlot overview – looking north east

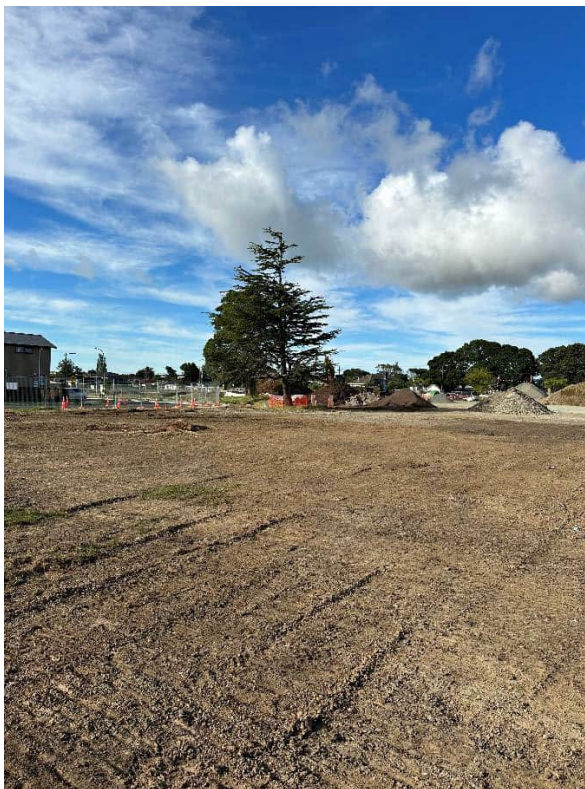
Photograph 4: Superlot overview – looking south west

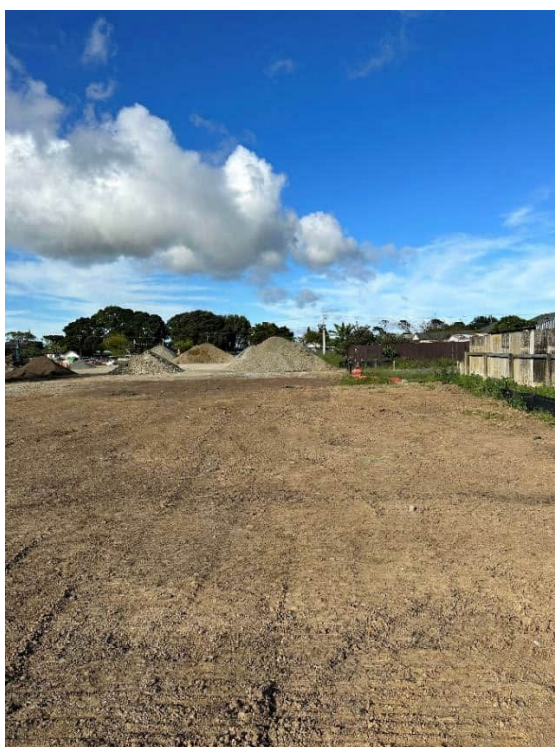
Photograph 5: Stockpile near the western boundary of the superlot

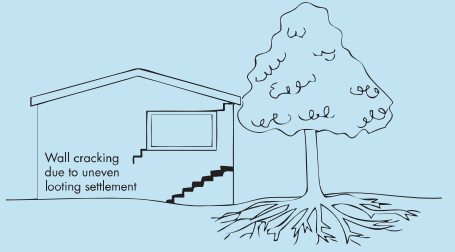
#### Trees can cause shrinkage and damage

external footings. The doming is accentuated and cracking reduces or disappears where it occurred because of dishing, but other cracks open up. The roof lines may become convex.
