Site Validation Report

Neighbourhood: Aorere	Stage: 2	Superlot: AO-019
<p>Introduction (Objective and scope):</p> <p>This Site Validation Report (SVR) has been prepared for the Piritahi site located across 1 Winthrop Way and 35 Henwood Road (AO-019). The site, which covers a total area of approximately 1384 m², will be part of a larger residential housing re-development. The purpose of this report is to verify that identified impacted soil has been removed from the subject site. This SVR summarises the remedial ground works programme, the validation process, and documents the condition of the site post the earthworks undertaken to remove the impacted soil.</p> <p>Pre-remediation site contamination</p> <p>The pre-remediation site contamination conditions are detailed in the Piritahi, Site Specific Remediation and Management Plan¹ (SSR&MP) AO-019. In summary, the following soils requiring remediation were identified:</p> <ul style="list-style-type: none"> Metals (specifically arsenic and lead) were reported above NESCS² residential (10% produce) land use soil contaminant standards (SCS) and the AUP permitted activity (PA) criteria³. <p>The remedial areas and associated soil sample r

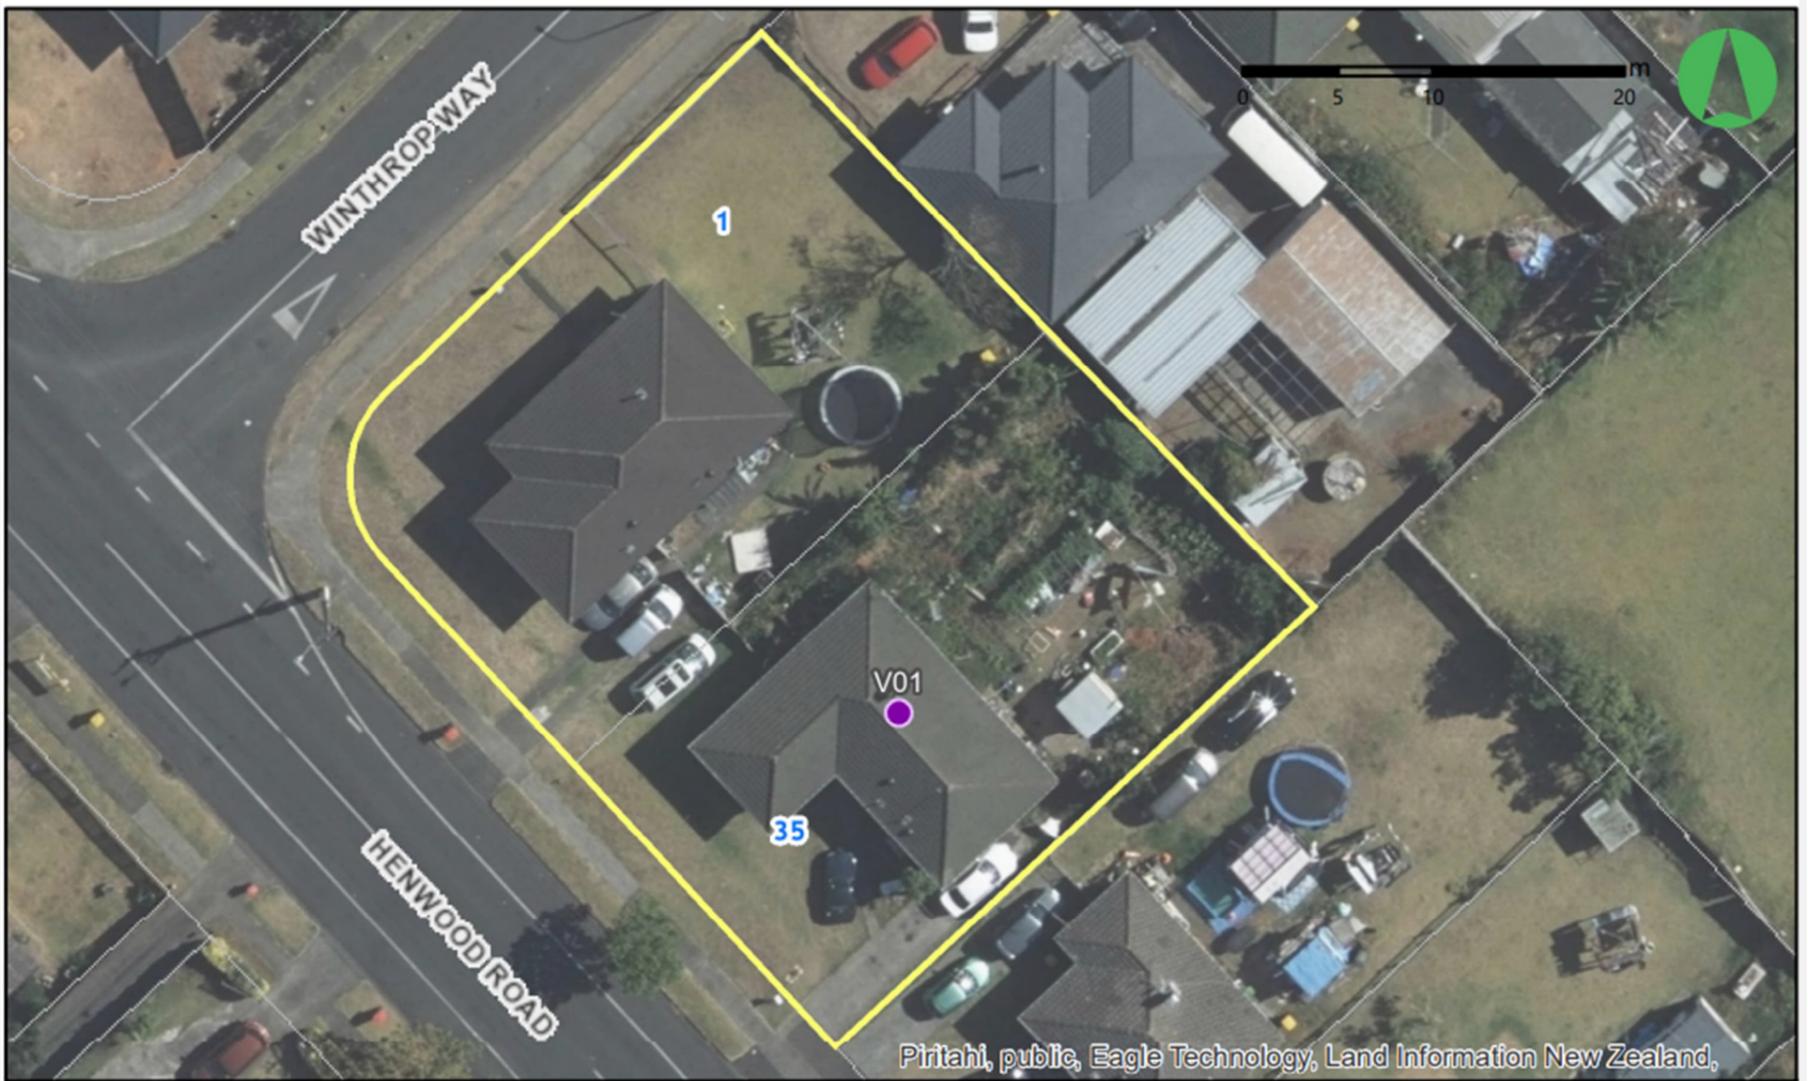
Figure 2 - Validation Sample Locations

Summary of works	
Location and dimensions:	Remedial works comprised the excavation and removal of surficial soil as follows: <ul style="list-style-type: none"> At 35 Henwood Road the vicinity of the dwelling was excavated to 300 mm below ground surface (bgs) and a portion of the rear garden was excavated to a depth of 500 mm bgs as shown on the pre-remediation investigation and remedial excavation figure in Appendix A; Soil surrounding redundant utility services that were removed during the works.
Variations from the SSRAP	No variations from the approved SSRAP occurred during these works.
Asbestos Management:	The following asbestos-in-soils management was implemented in accordance with the BRANZ guidelines during the works: In accordance with Piritahi procedures, unlicensed asbestos works controls were implemented across the remedial areas.
Duration of remedial works:	Works commenced on 16 May 2022 and were completed on 26 May 2022.

<p>Final site condition:</p> <ul style="list-style-type: none"> Identified impacted soil has been successfully removed from the site and validation samples indicate that the remediation goal was achieved. Based on the final validation results, no additional monitoring or management (beyond standard earthwork controls) is deemed to be required for the ongoing development and use of the site.
