Site Validation Report

Neighbourhood: Aorere	Stage: 2	Superlot: AO-015
<p>Introduction (Objective and scope):</p> <p>This Site Validation Report (SVR) has been prepared for the Piritahi site located across 29, 31, 33, and 35 Winthrop Way and 70, 72, 74, and 76 Mayflower Close (Ao-015). The site, which covers a total area of approximately 5,614 m<sup>2</sup>, will be part of a larger residential housing re-development. The purpose of this report is to verify that identified impacted soil has been removed from the subject site. This SVR summarises the remedial ground works programme, the validation process, and documents the condition of the site post the earthworks undertaken to remove the impacted soil.</p> <p>Pre-remediation site contamination</p> <p>The pre-remediation site contamination conditions are detailed in the Piritahi, Site Specific Remediation and Management Plan<sup>1</sup> (SSR&amp;MP) AO-015. In summary, the following soils requiring remediation were identified:</p> <ul style="list-style-type: none"><li>Metals (specifically cadmium, copper and lead) were reported above NESCS<sup>2</sup> residential (10% produce) land use soil contaminant standard (SCS); and</li><li>

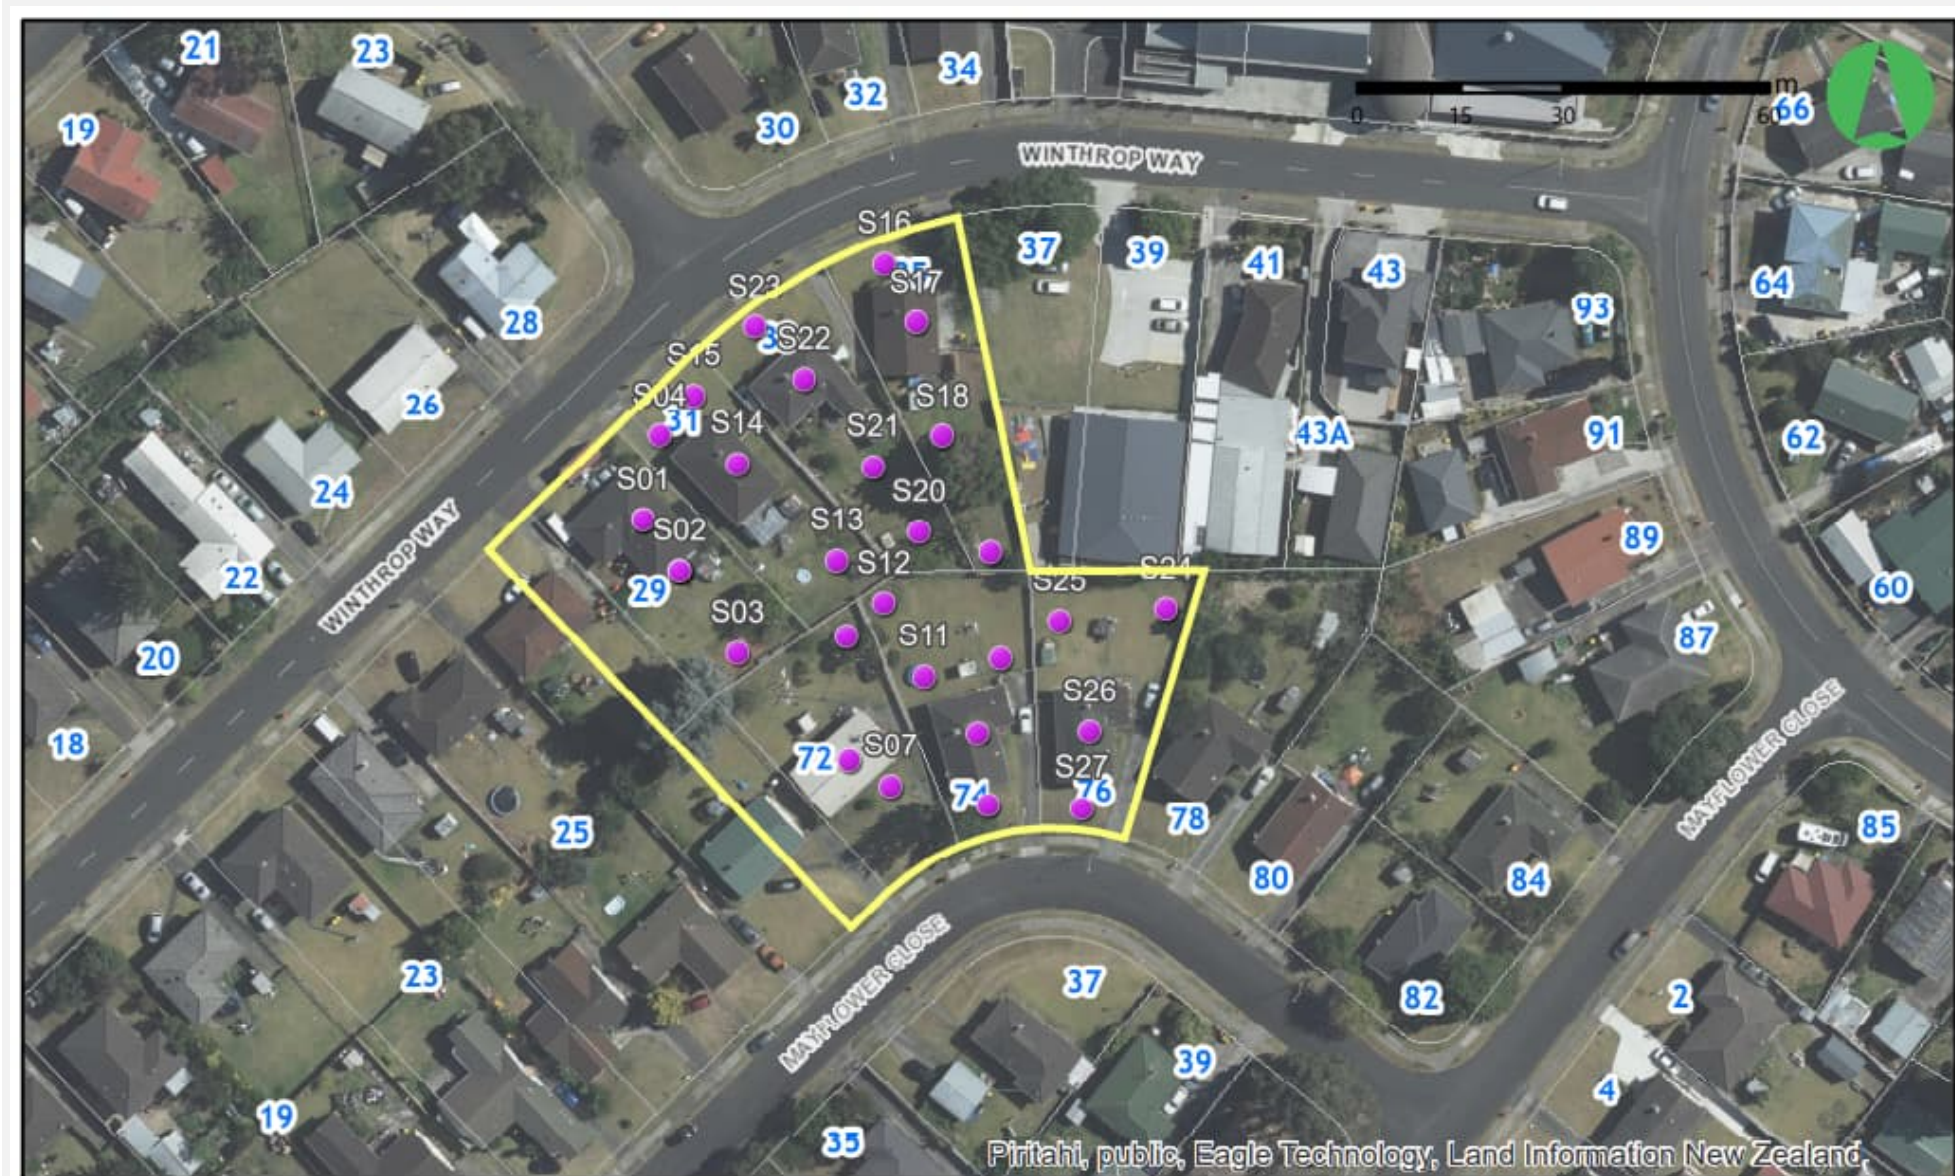
Figure 1 - Pre-validation sampling plan

Pre-Validation sampling plan

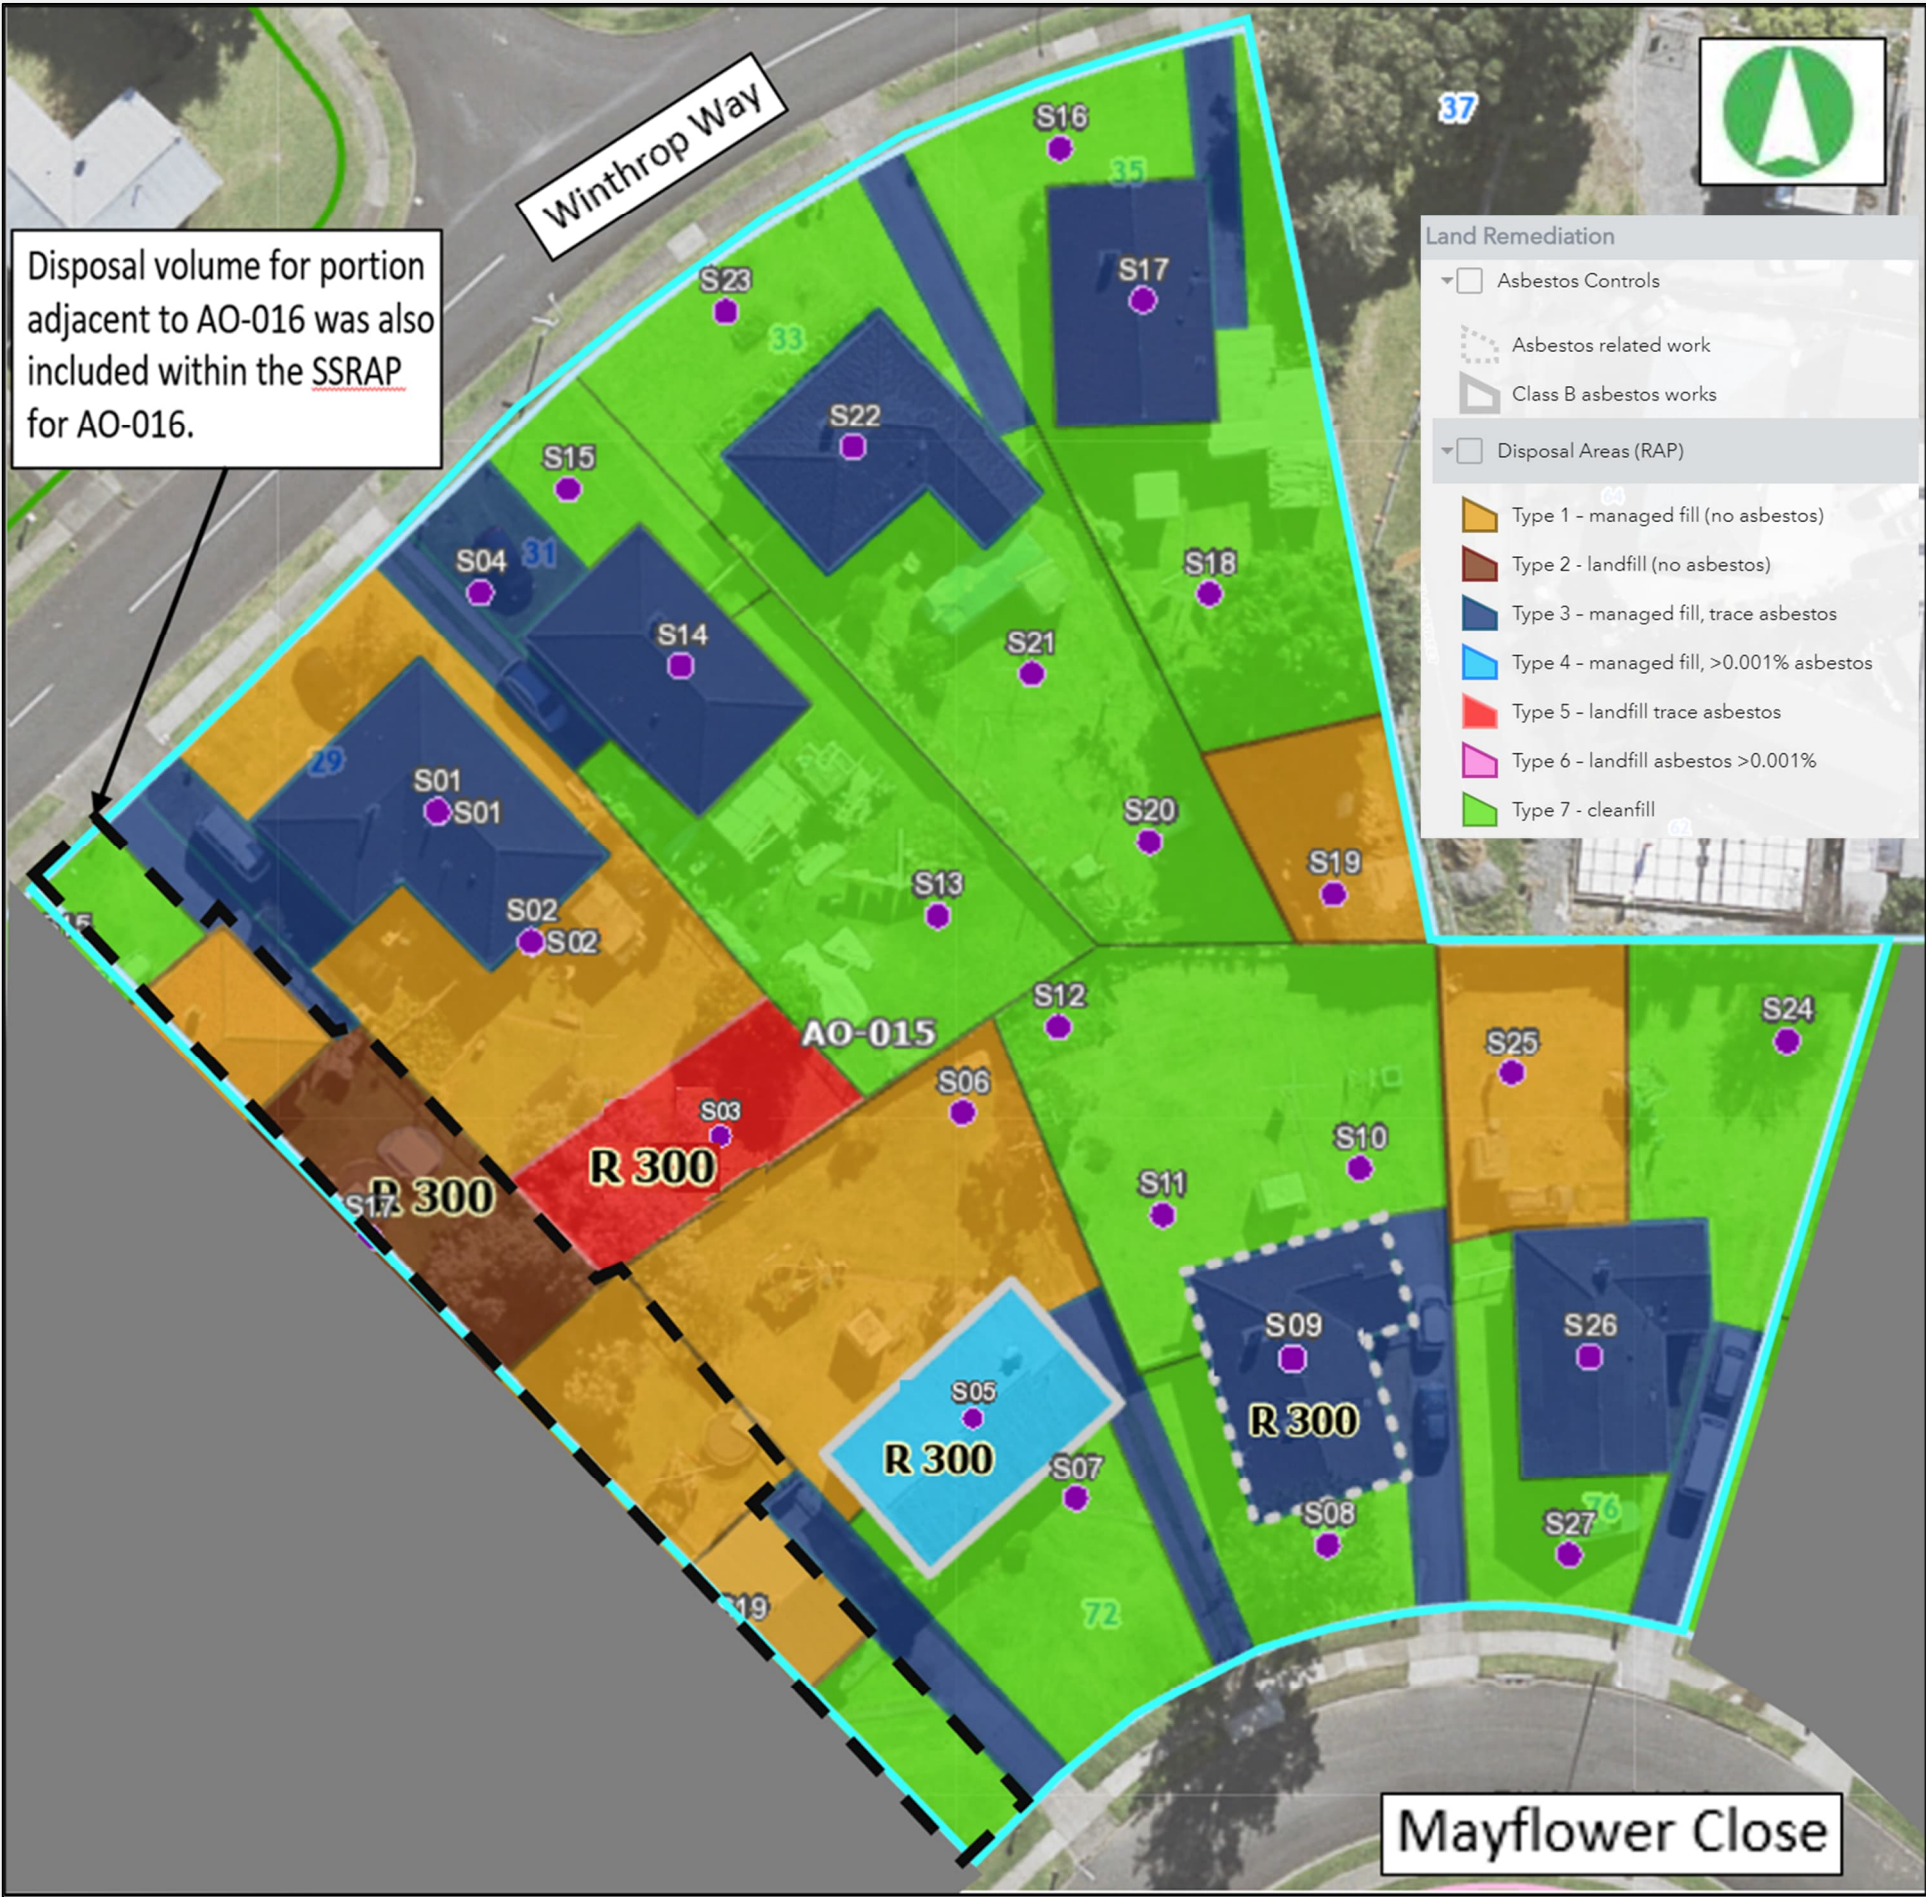
Figure 2: Off-site soil disposal plan and asbestos controls

Note that all "R" areas were pre-validated except locations S05 and S09, which were validated for asbestos post soil removal

Asbestos Management:	<p>The following asbestos-in-soils management was implemented in accordance with the BRANZ guidelines during the works:</p> <ul style="list-style-type: none"><li>Class B asbestos soil removal in the footprint of 74 Mayflower Close, as shown on Figure 2 overpage.</li><li>Class B asbestos soil removal in areas surrounding redundant utility service trenches.</li><li>Asbestos related work involving removal of low-level asbestos impacted soil at the footprint of 74 Mayflower Close.</li></ul> <p>In accordance with Piritahi procedures, unlicensed asbestos works controls were implemented across the remainder of the Superlot.</p>
Duration of remedial works:	Works commenced on 13 April 2022 and were completed on 20 May 2022.
Soil removal and disposal:	370 Tonnes (See attached Disposal Summary)
EnviroFill South	Some 70 tonnes were disposed at EnviroFill South as trace asbestos soil.

Hampton Downs	A total of some 155 tonnes was disposed to Hampton Downs Landfill, some 60 tonnes as metals contaminated with asbestos and some 95 tonnes as metals contaminated soil.
Whitford Landfill	Some 145 tonnes of class B asbestos soil were disposed to Whitford Landfill from the footprint of 72 Mayflower Close and surrounding redundant utility service trenches from various locations across AO-15.
Imported material:	No soil was imported to site (Condition 30 of the consents)
Unexpected discoveries:	No unexpected discoveries outside of expected soil contamination were reported during the remediation works.
Complaints and incidents	No complaints or safety or environmental incidents related to soil contamination were reported during the remediation works.

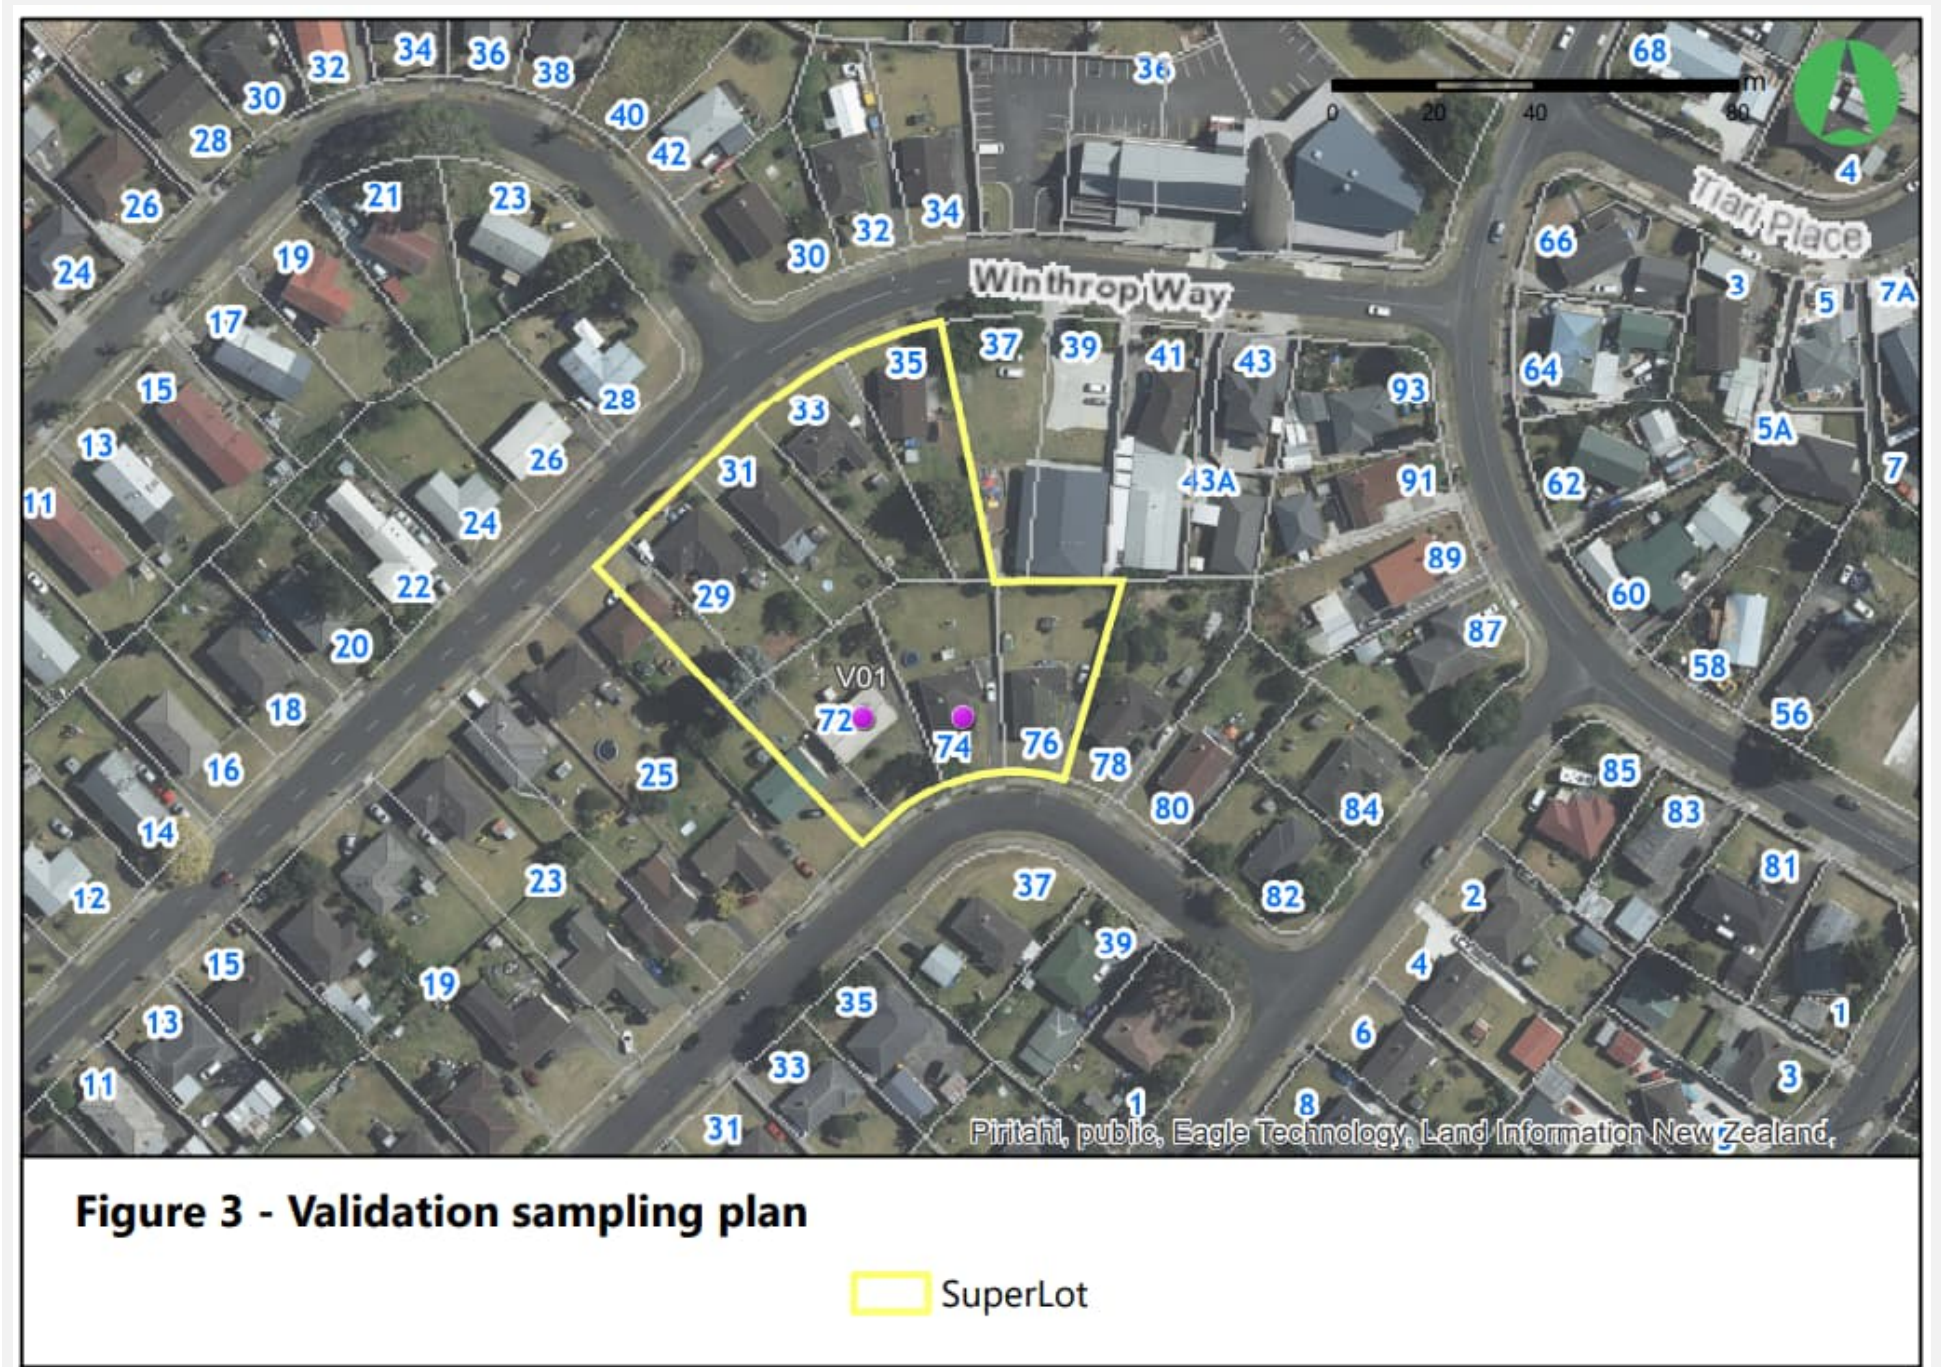
Validation sampling plan

A visual inspection of the cut surface was undertaken prior to the collection of validation samples. A total of two validation soil samples (V01 and V02) were collected from the AO-015 remediated area (all other locations were pre-validated during investigation). The validation samples were analysed for the presence / absence of asbestos by International Accreditation New Zealand (IANZ) accredited laboratories using industry standard methods. Laboratory transcripts are provided Appendix A and tabulated below.

Soil samples collected and analysed as part of the validation works reported no asbestos detections.
