AORERE STAGE 2 – TOC45

Superlot AO-016

Geotechnical Completion Report

AORERE STAGE 2 – SUPERLOT AO-016– GEOTECHNICAL COMPLETION REPORT

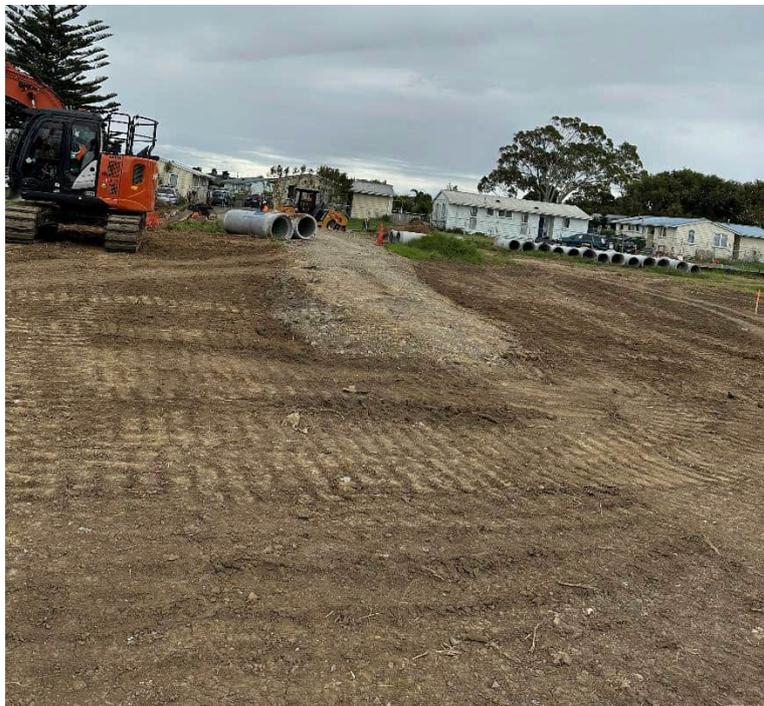
Photograph 4: Hardstand near the northern boundary (entrance) of the superlot

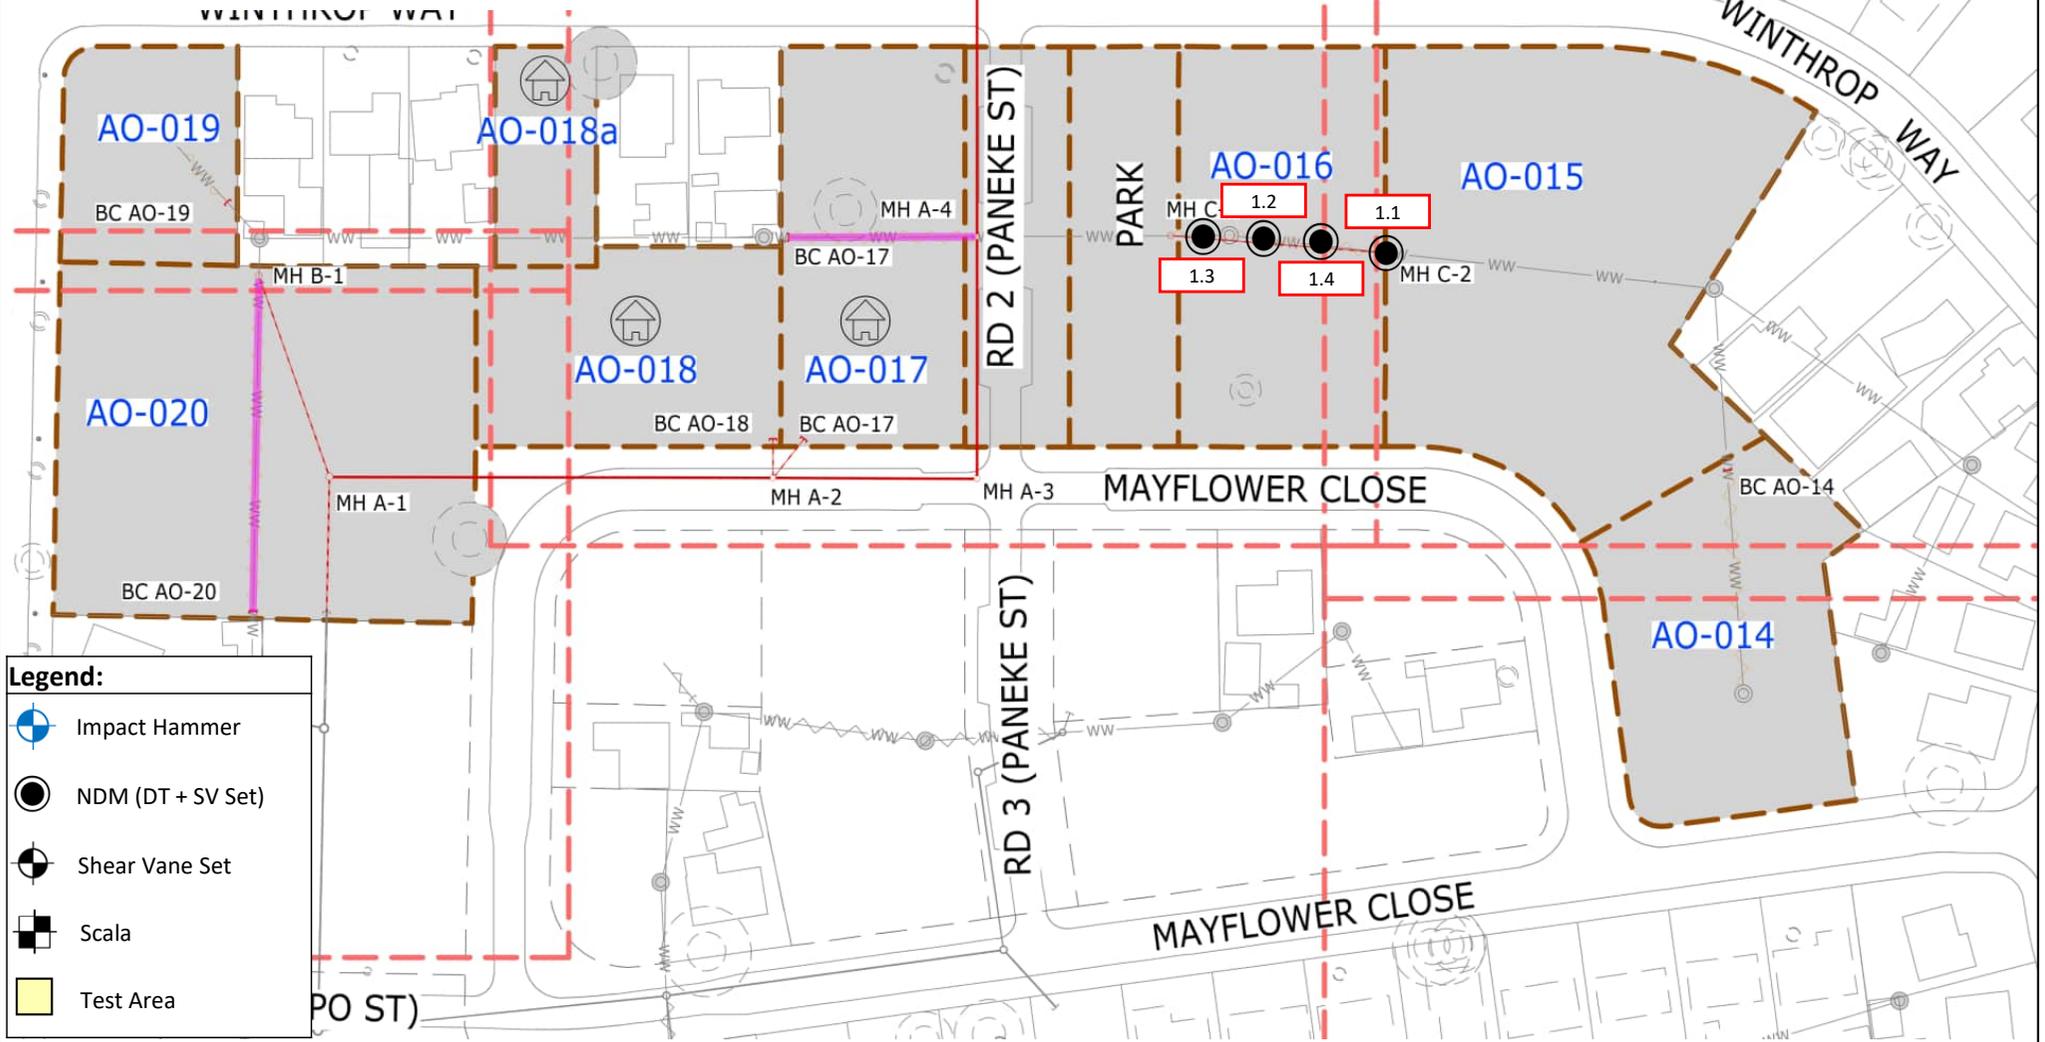
Test Location Plan

Site:	Mangere Precinct TOC45	Job Name:	TOC45-Mangere-Aorere-Stage 2-DIM086/CIM086	Drawn:	KELF	Date:	25/01/2023
Location:	Superlot AO-016 MH C-1 – MH C-2	Job No.:	1041000.0045.1.0/Rep	URN:	1	Date:	25/01/2023
		Lab Ref:	- N/A	Scale:	Not to Scale	Rev.:	1

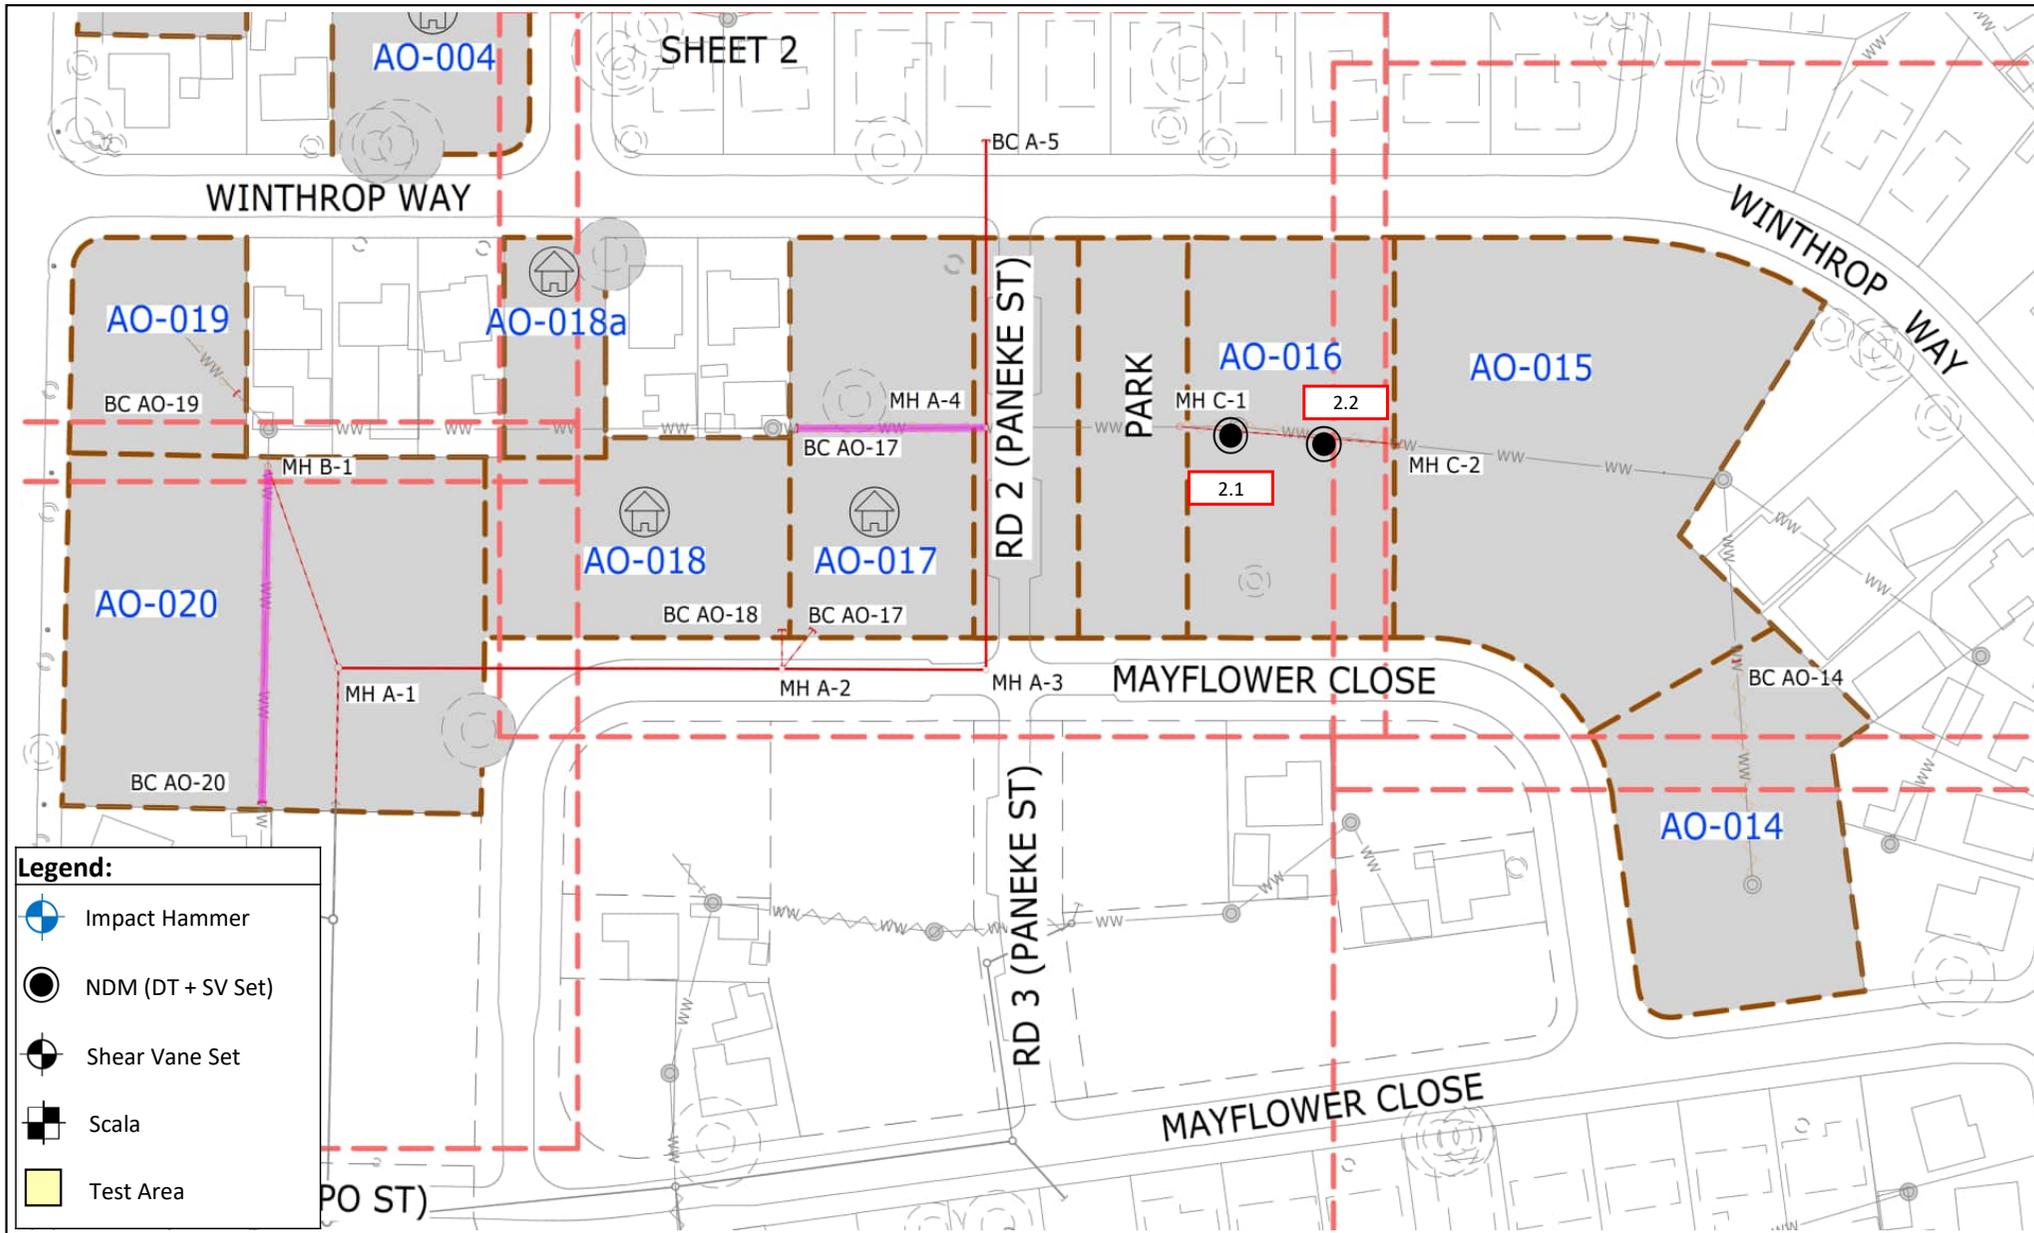
Test Location Plan				PROVISIONAL			
Site:	Mangere Precinct TOC45	Job Name:	TOC45-Mangere-Aorere-Stage 2-DIM086/CIM086	Drawn:	IBSI	Date:	09/02/2023
Location:	Superlot AO-016 MH C-1 – MH C-2	Job No.:	1041000.0045.1.0/	URN:	2	Date:	10/02/2023
		Lab Ref:	- N/A	Scale:	Not to Scale	Rev.:	1
